UNIVERSITY
OF TRENTO - Italy

Doctorate School in Materials Engineering – XXI cycle

Studies on concrete degradation in aggressive environment and development of protective system

Fabrizio Girardi

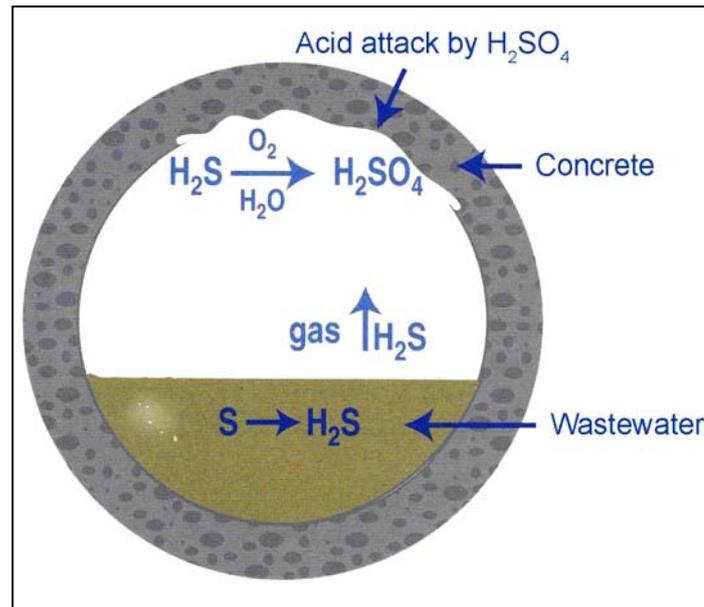
The processes leading to corrosion of the concrete sewer pipes are really complex. As previously described by some authors [1-15,22], hydrogen sulphide produced by anaerobic wastewater is released into the flowing wastewater. Then, it diffuses into the atmosphere and re-dissolves in the condensate on the portion of the pipe above the wastewater, where micro-organisms, such as *Thiobacillus thiooxidans*, growing on this surface, convert aerobically hydrogen sulphite to sulphuric acid, which reacts with the concrete [9]. In most cases the pH on the surface is very low (in the worst case the pH is 0.5) [19]. The scheme of this process is reported in Figure 1.

Figure 1 – Sewer pipe degradation scheme

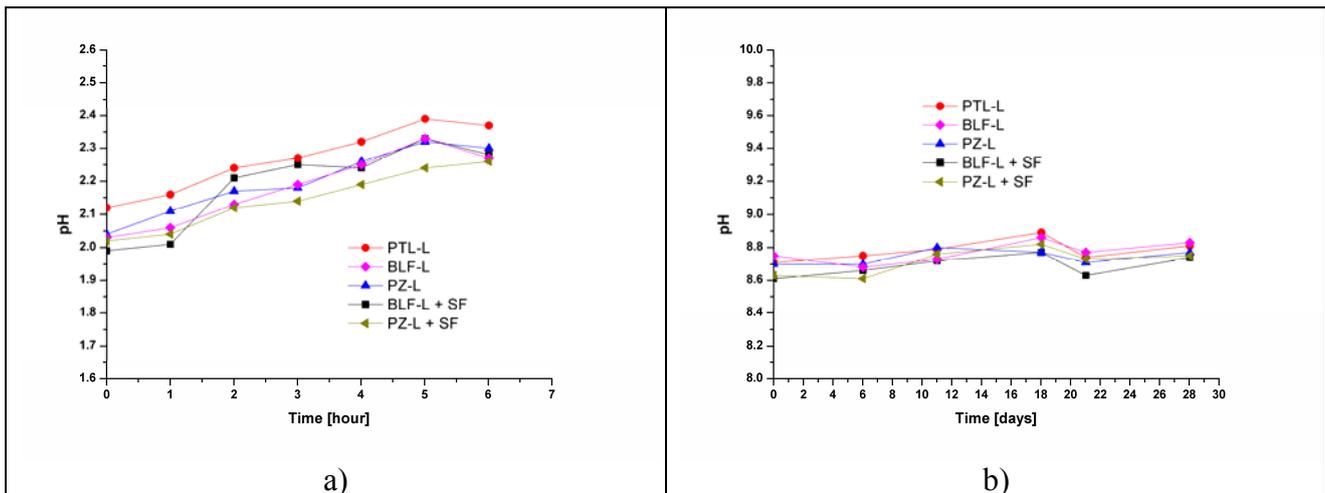
Figure 2 – pH values during acid attack (a) and during sulphate attack (b)

During the 6 hours of acid attack, the pH increases from 2 to 2.3 because degradation products release into the solution. In the case of the sulphate attack the pH values of every samples is stable in a range between 8.6 and 8.8 .

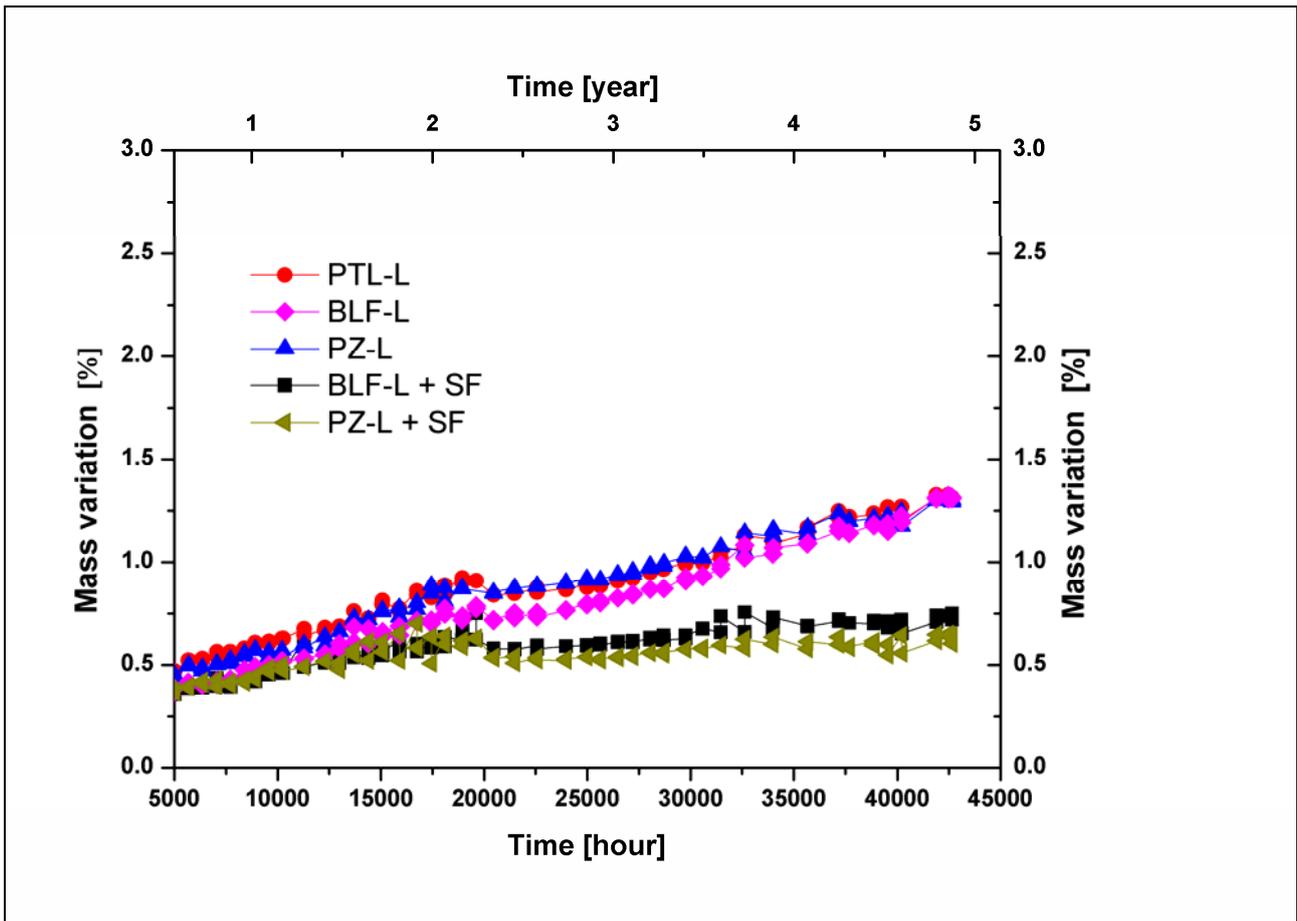
The concretes were prepared in accordance with EN 206 for the XA3 class with $w/c \leq 0.45$ and $R_{ck} \geq 45$ MPa. Figure 3 shows the mass variation vs. time during the sulphate attack in sodium sulphate (50 g/l Na_2SO_4). The trend is similar for all the mixtures and two behaviours appear: a sharp increment of the sample mass occurs in the first week due to absorption of the solution; then a small mass variation takes place, especially for the mixture prepared without silica fume, due to formation mainly calcium sulphate.

Figure 3 - Mass variation [%] during the sulphate attack.

The rate of the mass variation in two different periods during the 5 years of testing is reported in Table 4. The behaviour is similar for all the specimens but, in the range between 20000 and 45000 hours, the samples prepared without silica fume show a rate one order higher than the others prepared with silica fume. In general the specimens, in sodium sulphate solution, don't have evident degradation until 45000 hours of testing.

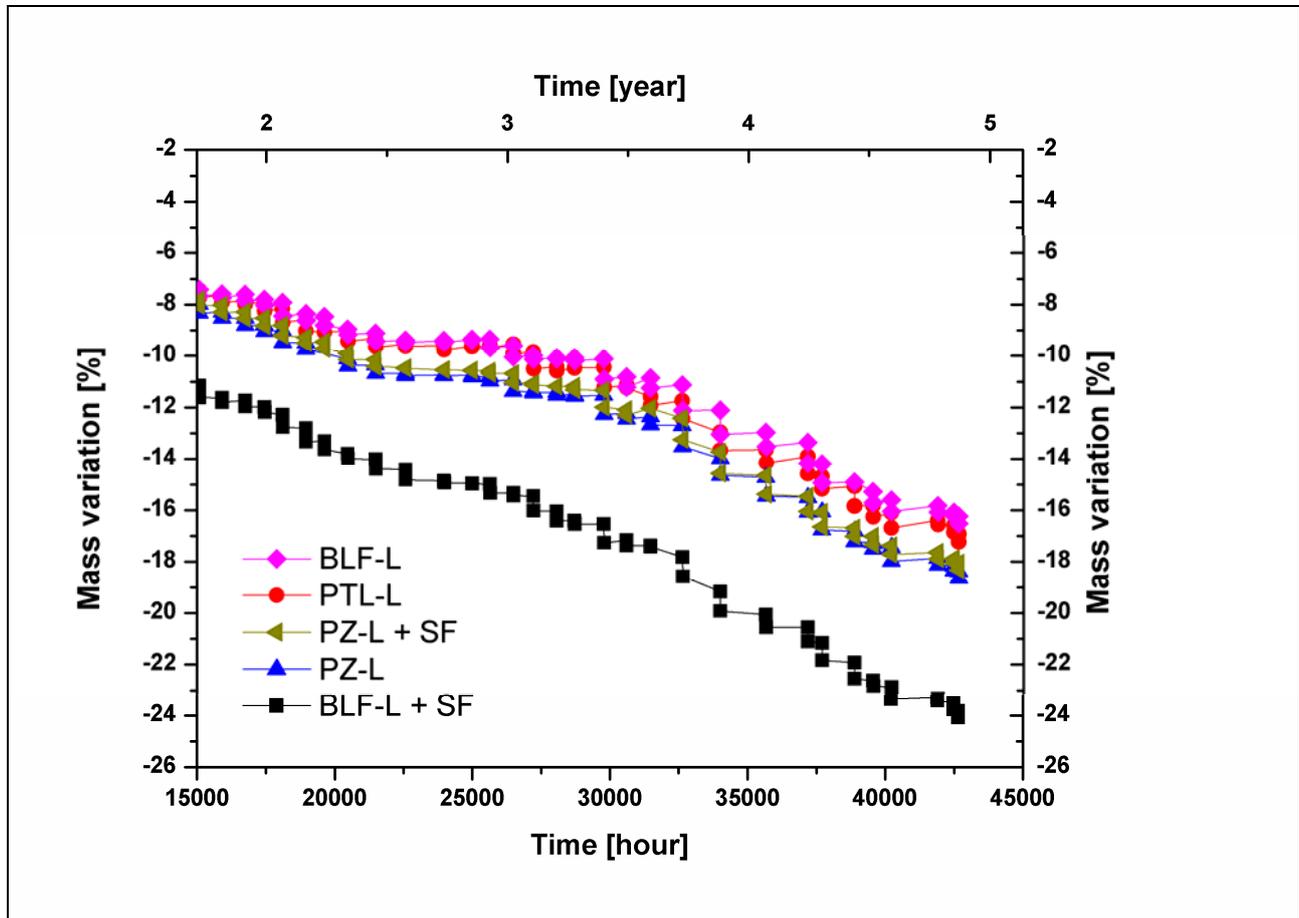
Figure 4 - Mass variation [%] during the cyclic acid/sulphate attack.

The sample mass is steady during the immersion in sulphate solution, but decreases during the acid attack. There are two regimes of mass variation: in the first the degradation rate is high when the acid attack occurs weekly; it is low in the second one, when the attack is monthly. The corrosion rates are calculated as the slope of the best linear interpolation of the experimental points, and are reported in Table 5.

The slopes are similar in the period between 2000 and 5000 hours, but in the others two, the BLF-L + SF has a high mass loss ($\Delta m = -24\%$ after about 5 years) [9]. The difference between the first and the second corrosion regimes depends on the frequency of the acid attack with sulphuric acid. The silica fume affects negatively the resistance to this attack. The sulphuric acid attacks both the cement phase and the carbonate aggregate. The portlandite and the C-S-H react with the sulphuric acid forming calcium sulphate and anhydrite, which are more soluble than portlandite. Also, aggregates are covered by incoherent calcium sulphate from the reaction with the acid. This is due to the high percentage of aggregate in concrete, which contributes more than cement paste to surface depletion.

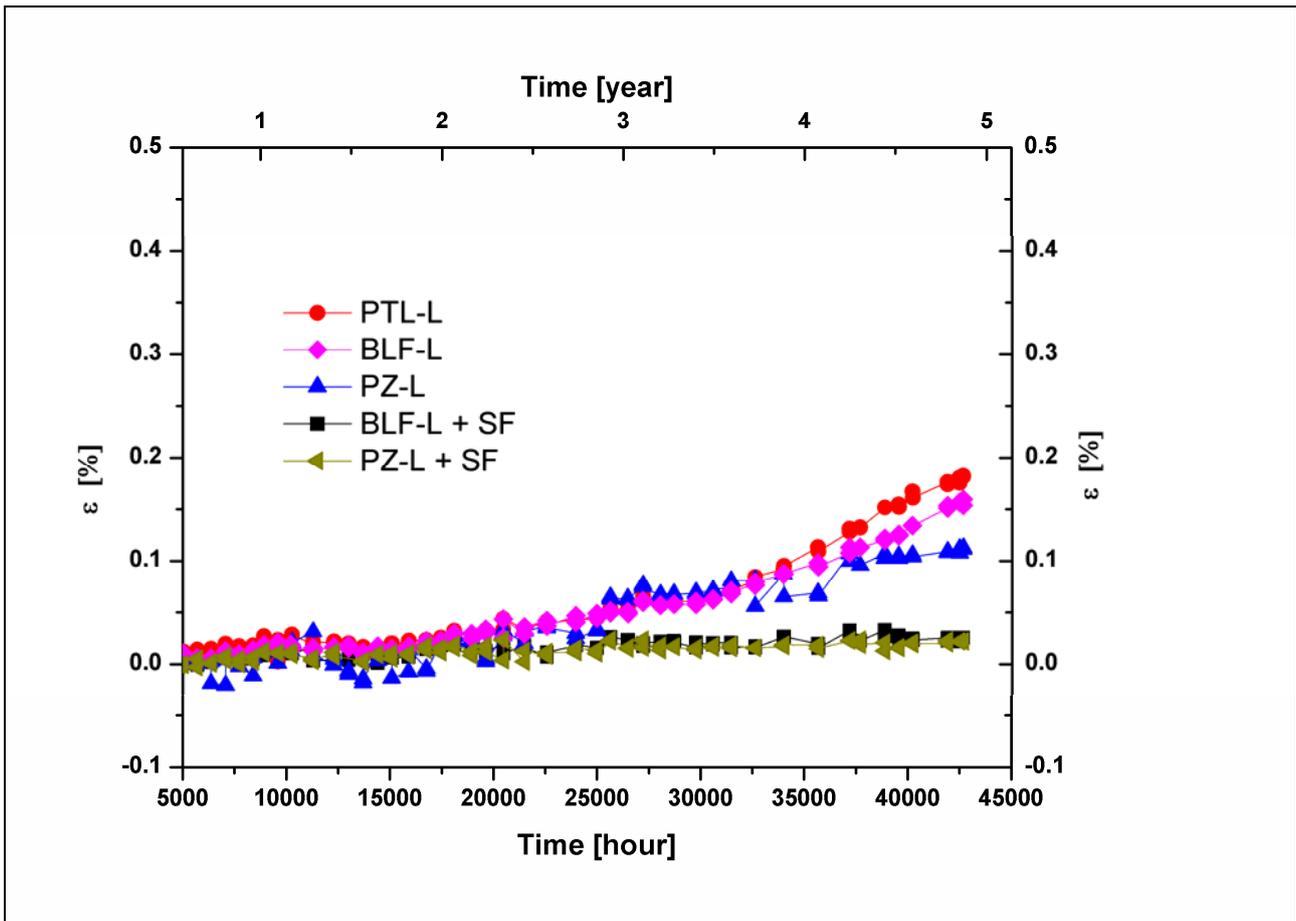
Figure 5 shows the deformation percentage of the samples subjected only to sulphate attack. The sample length is steady during the sulphate attack but, after 15000 hours, a remarkable expansion is recorded, especially for the mixtures prepared without silica fume. The slopes of the straight line of the expansion in three different periods are reported in Table 6

Figure 5 – Deformation [%] during the sulphate attack.

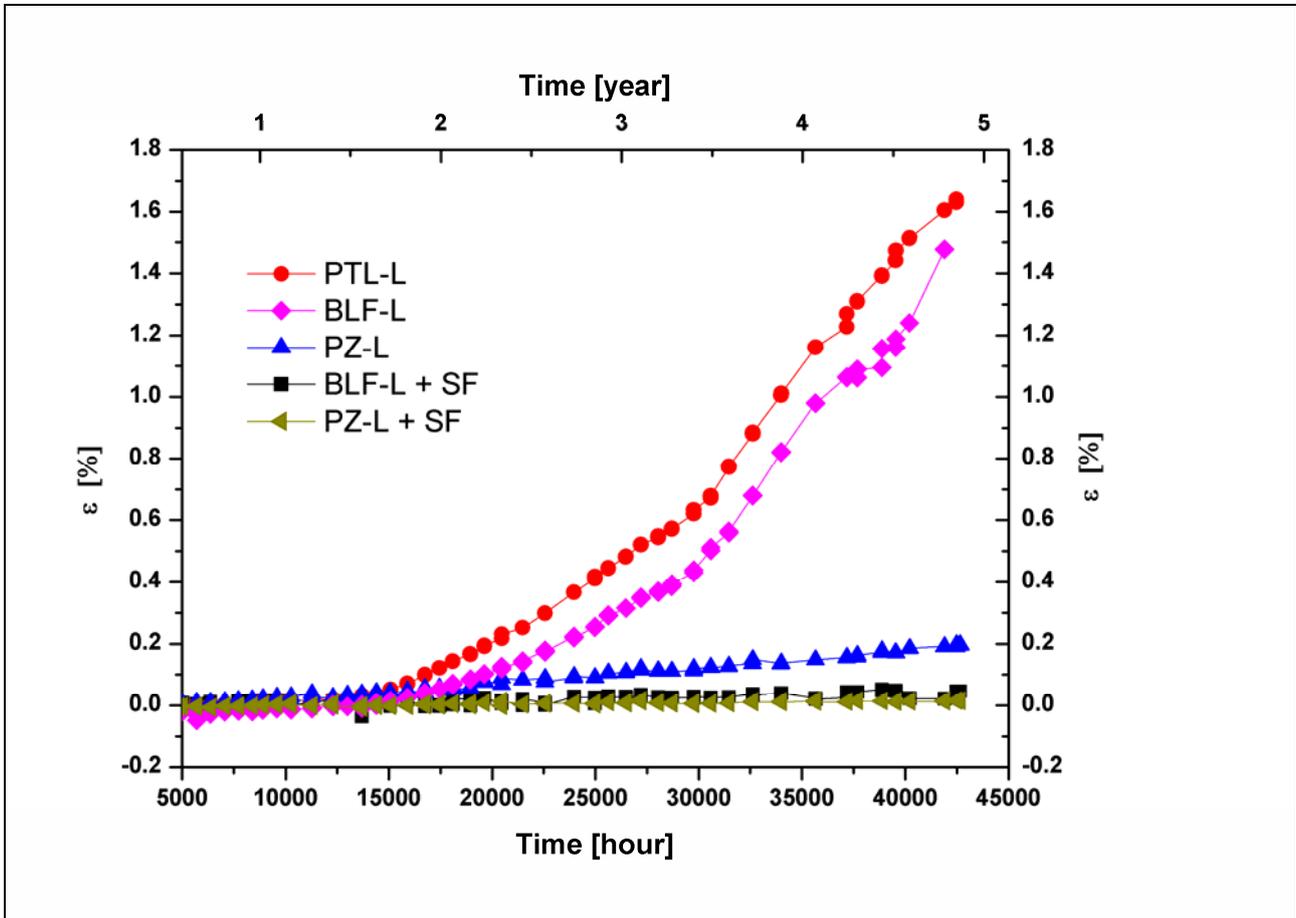
The deformations of all specimens subjected to the cyclic acid and sulphate attack are reported in Figure 6. It is clear that, just after 13000 hours, PTL-L and BLF-L show a remarkable expansion.

Figure 6 - Deformation [%] during the cyclic acid/sulphate attack.

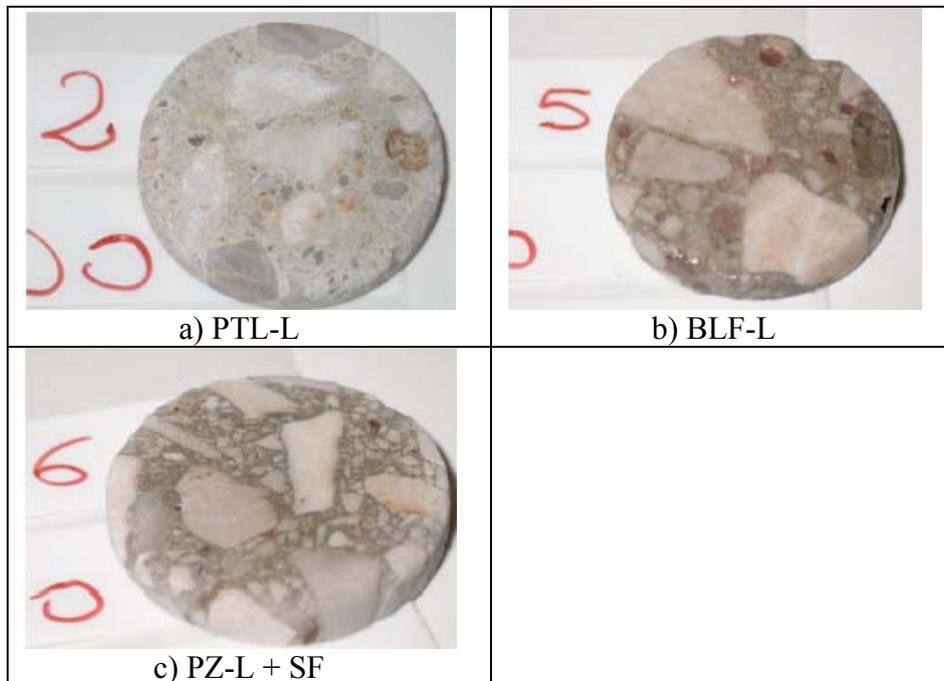
After 2000 hours of testing, a slice from each sample subjected to acid/sulphate attack, was cut and used for microstructural analysis. Using phenolphthalein test (EN 9944), the external cutting surface and the core were analyzed: there was an acceptable basic level (Figure 7).

Figure 7 – Phenolphthalein method results (EN 9944) on three mixtures (a) PTL-L, b) BLF-L and c) PZ-L+SF) after 2000 hour of acid/sulphate attack.

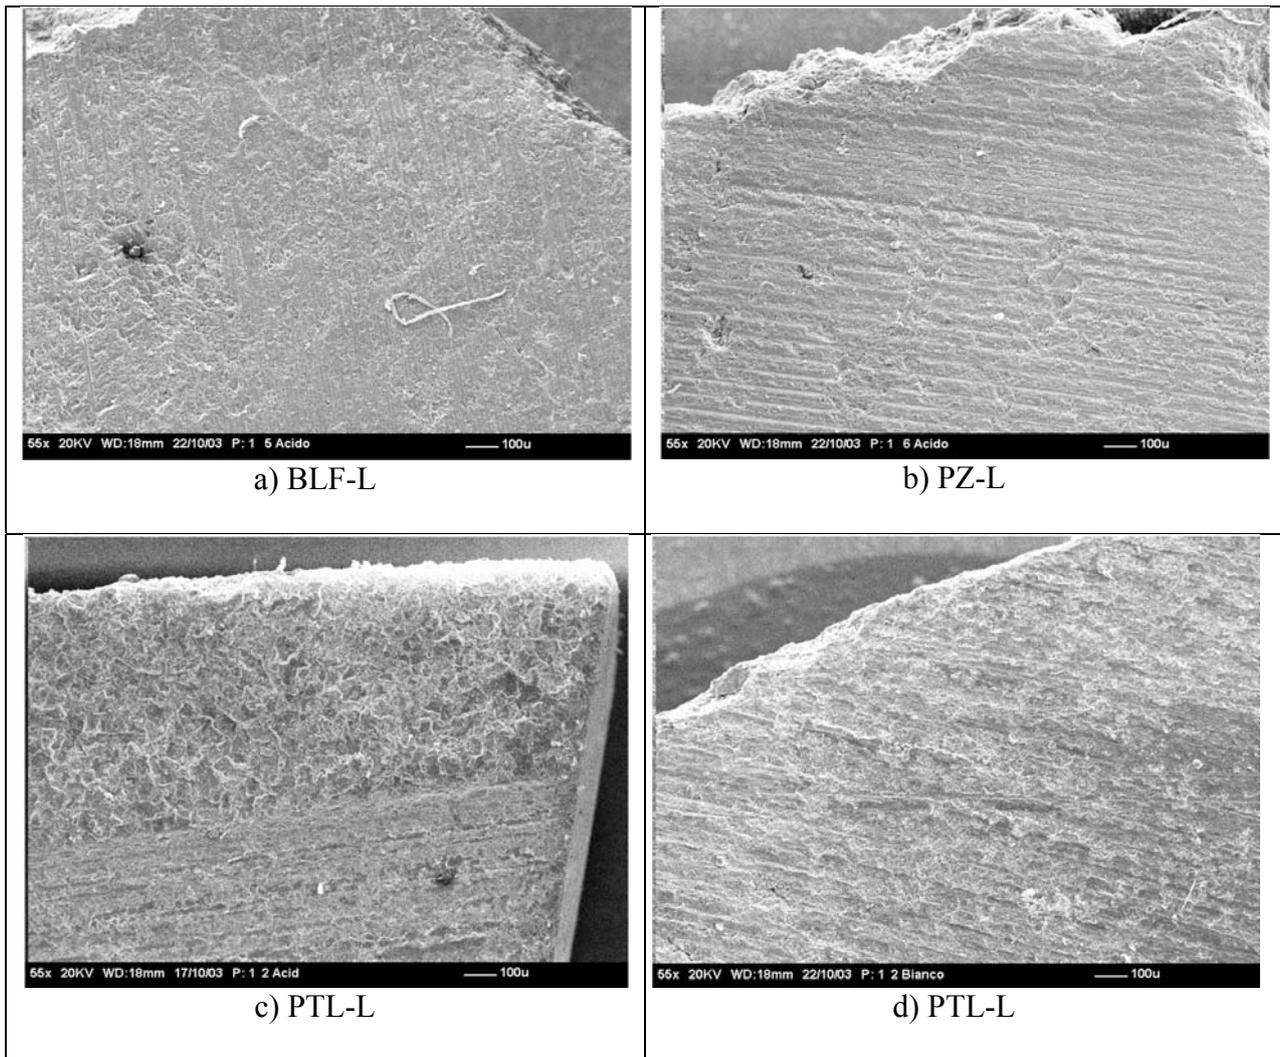
The micrographs of the same samples analysed with the phenolphthalein test are reported in Figure 8.

Figure 8 – Micrographs of the mixtures BLF-L, PZ-L + SF and PTL-L (a, b and c respectively) after 2000 hours of acid/sulphate attack and the PTL-L (d) after 2000 hours of only sulphate attack.

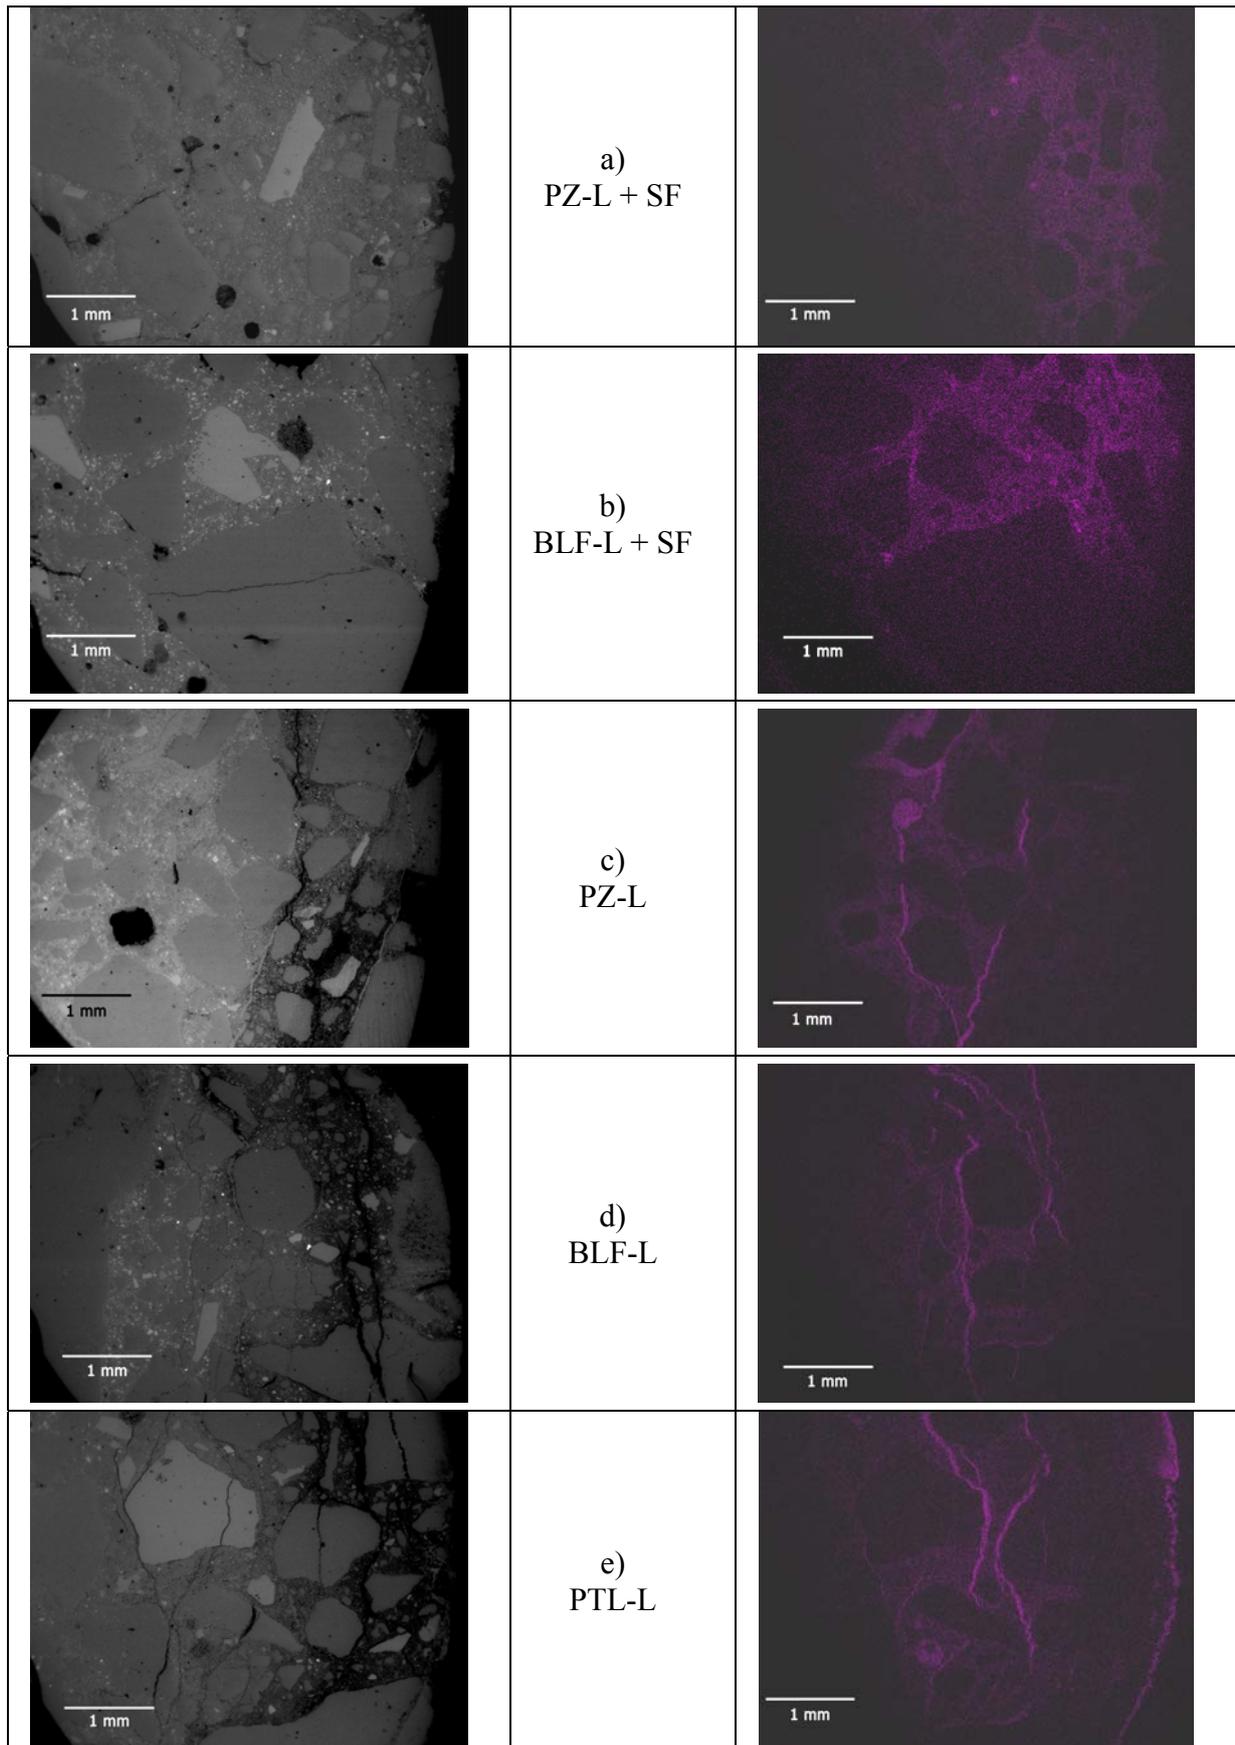
Figure 10 - ESEM images (on the left) and X-ray maps for sulphur (on the right) of polished surface subjected to cyclic acid/sulphate attack.

For the mixtures prepared adding silica fume (PZ-L + SF and BLF-L + SF, Figure 10a and Figure 10b respectively), the surface of the sample doesn't show cracks neither a preferential path of the acid attack, which seems instead to provide a general erosion of the surface. This is confirmed by the X-ray map for sulphur of the same sample; there is no evidence of cracks, the sulphur is present in the voids and entrained air bubbles.

In the cutting surface of the sample with pozzolanic cement (Figure 10c), which showed a greater expansion compared with the first two previous ones, a few cracks appears quite clearly in the cement paste. As it can be seen in the corresponding X-ray map for sulphur, the cracks are filled of columnar crystals.

The micrographs of the concretes with blast furnace and portland cement (Figure 10d and Figure 10e, respectively), which showed both the largest expansion values, show an extensive cracking, observed around aggregates and through the paste, with occasional cracking through aggregate particles. The most of cracks appear black, due to the loss of material during the cutting and polishing of samples. Many of the internal cracks were filled with columnar crystals. This is confirmed by the X-ray maps which suggest that the acid attacks through a preferential path and afterwards sulphate phases crystallize.

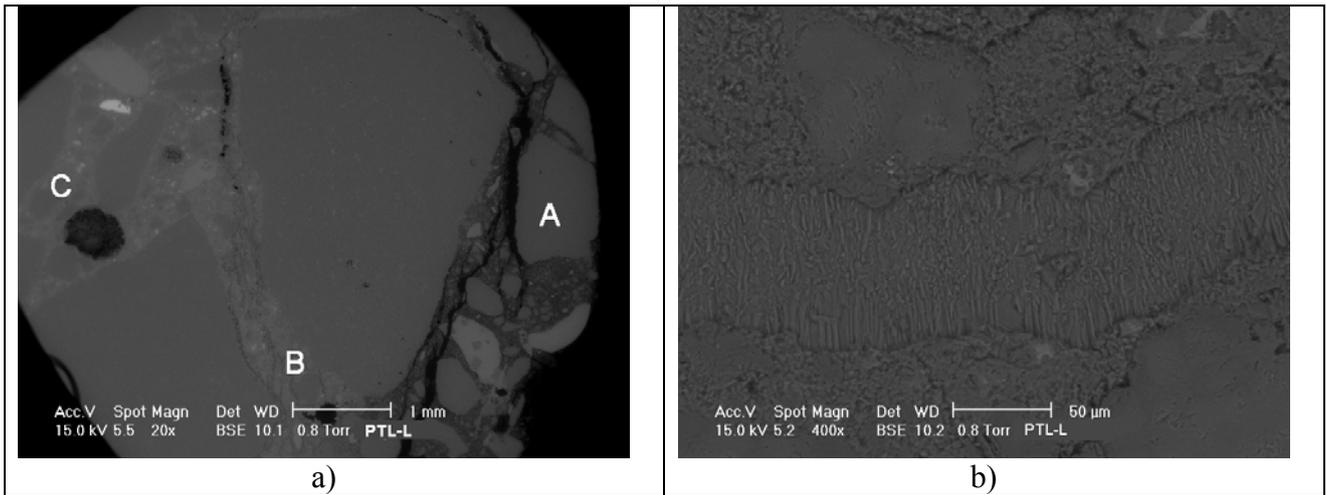
The concretes during cyclic acid/sulphate attack show a peculiar crack pattern, depending on the occurred mechanism. The PTL-L micrograph, after 45000 hours of cyclic acid/sulphate attack is reported in Figure 11a on the left, and shows a surface with three different zone: a zone with an high level of degradation (A), a zone of deposition of the attacks products (B) and an intact core (C). Details of the microstructure of the B zone are shown in Figure 11 b on the right.

Figure 11 - Micrographs of the PTL-L after 45000 hours of cyclic acid/sulphate attack.

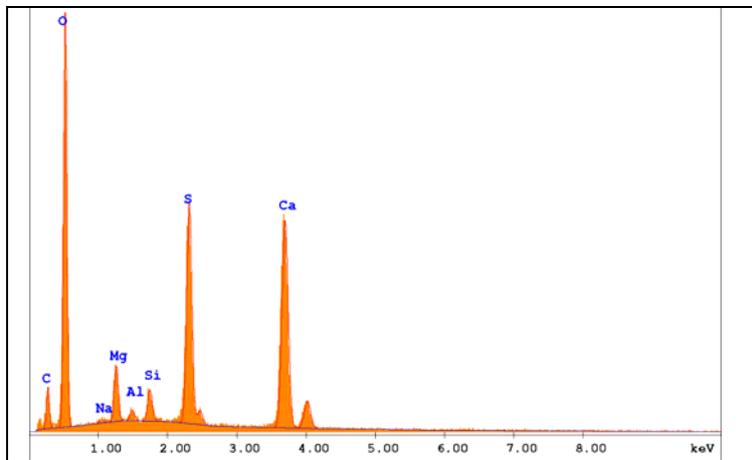
In the internal part of the crack, there are crystals of the degradation products, which are grown perpendicular to the crack direction. EDAX analysis (reported in Figure 12) confirms the high content of sulphur in the columnar crystals embedded into cracks, in an atomic Ca/S ratio (36.69/35.84) compatible with that of calcium sulphate [33], rather than that of ettringite.

Figure 12 – EDAX results of the crystals in the crack reported in Figure 11b.

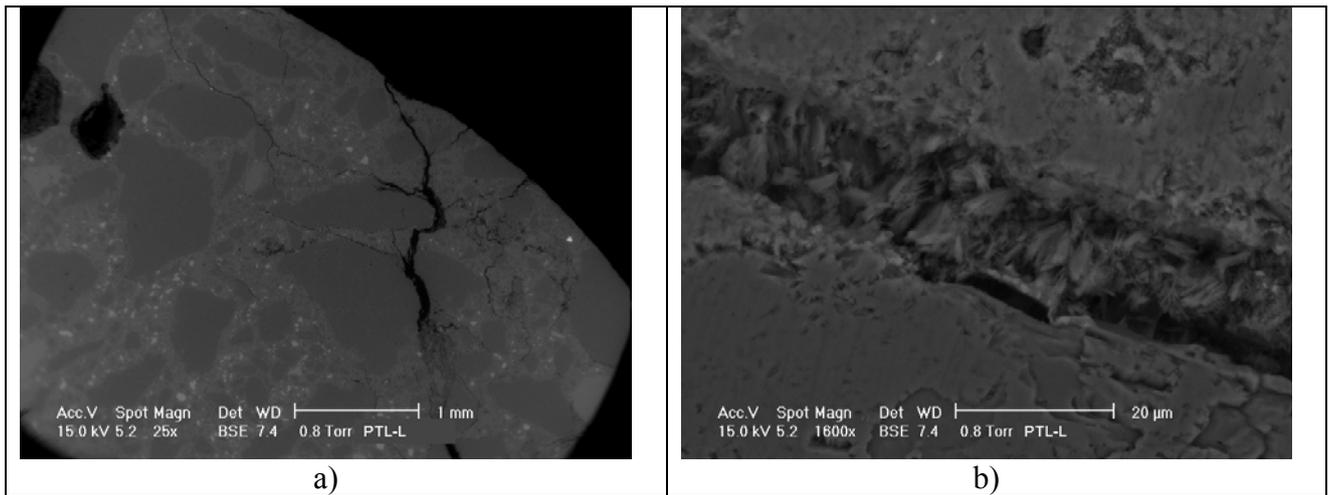
In Figure 13 the microstructures of the PTL-L of sulphate attack are reported. This specimen doesn't clearly show the three zones. Small cracks are present only in the external part of the section, where degradation products containing sulphur (as confirmed by the EDAX analysis) are visible (Figure 13 b).

Figure 13 – Micrographs of the PTL-L after 45000 hours of sulphate attack.

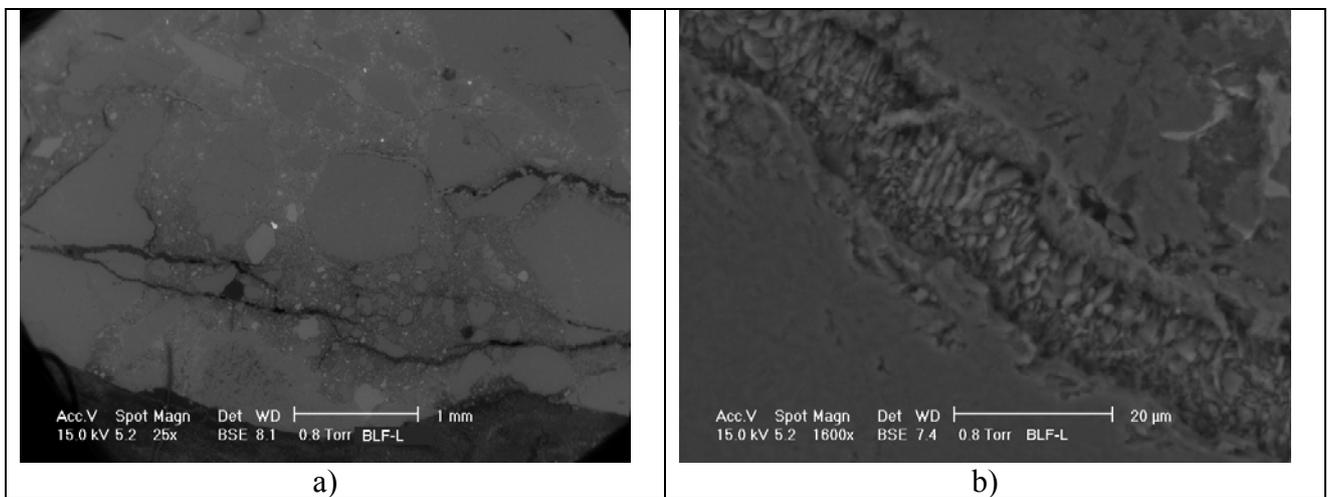
In Figure 14a the microstructure of the BLF-L after 45000 hours of cyclic acid/sulphate attack (on the left) is reported: the surface is compromised to the presence of cracks due to the expansion of the degradation products (Figure 14b), similarly to the sample subjected only to the sulphate attack.

Figure 14 – Micrograph of the BLF-L after 45000 hours of cyclic acid/sulphate attack.

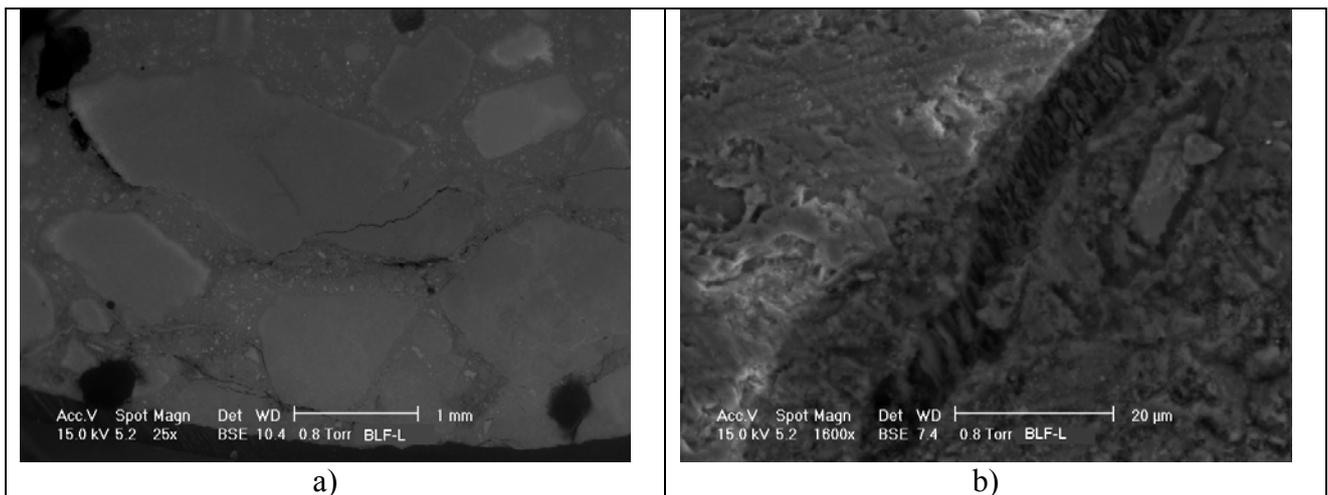
Figure 15 shows the micrographs of the BLF-L sample after 45000 hours of sulphate attack. The degradation is similar to that of the acid attack, but the crystals are thin with a needle form.

Figure 15 – Micrograph of the BLF-L after 45000 hours of sulphate attack.

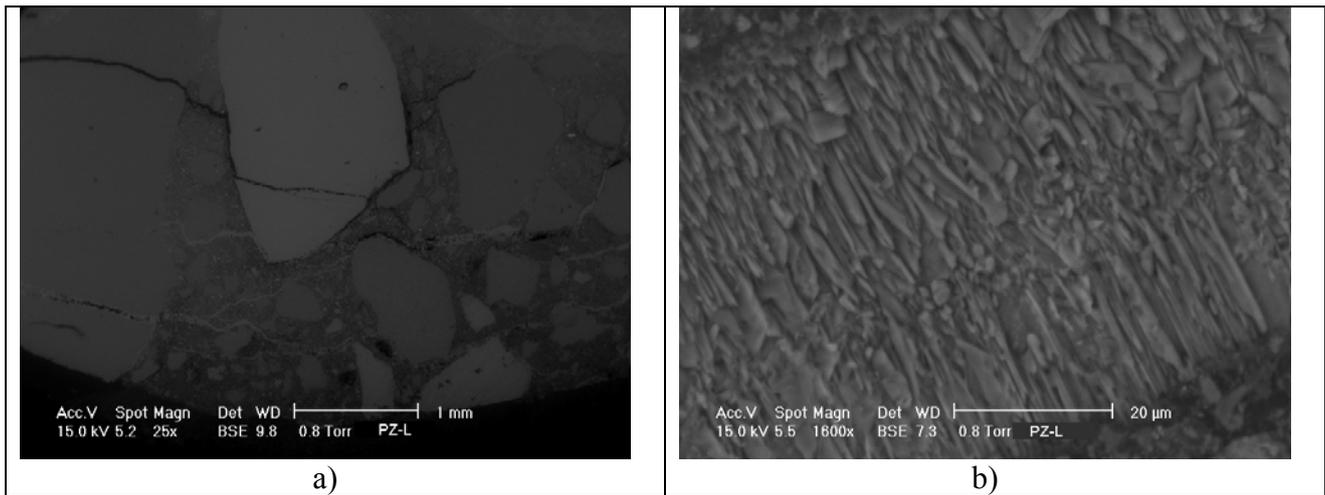
The concrete prepared with the PZ-L doesn't show a remarkable degradation but, only little cracks within expansion products in the cement matrix and in some aggregates, as reported in Figure 16a. The crystals in the crack are very large, in some cases over 40 microns (Figure 16b) and the EDAX analysis (reported in Figure 17) confirms the high content of sulphur in the columnar crystals embedded into cracks, in an atomic Ca/S ratio (32.72/32.29) compatible with that of calcium sulphate [33], rather than that of ettringite.

Figure 16 – Micrograph of the PZ-L after 45000 hours of cyclic acid/sulphate attack.

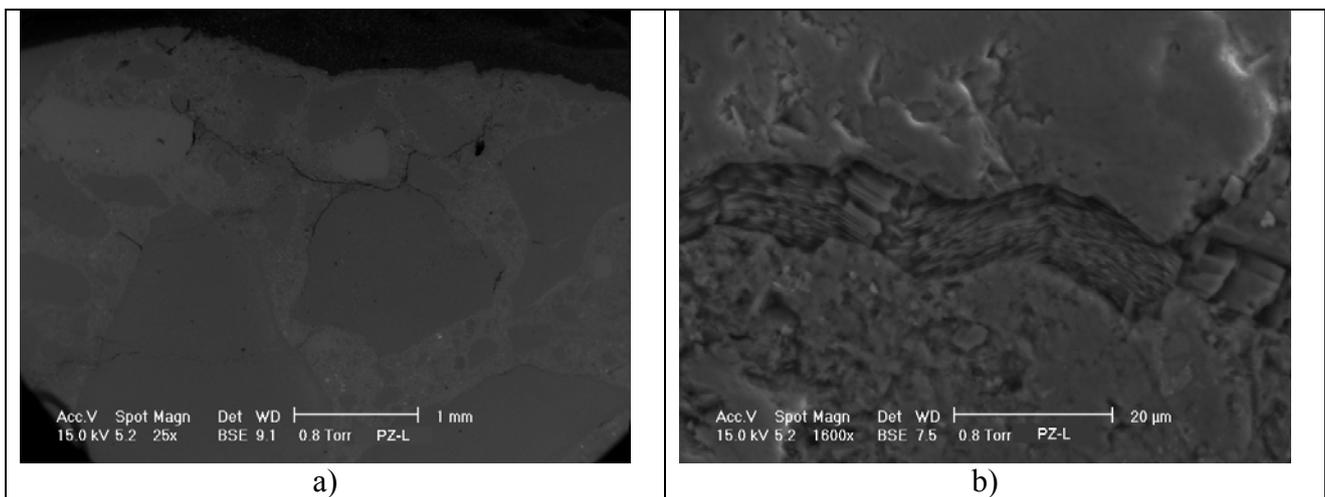
The micrographs related to the pozzolanic cement without silica fume during the sulphate attack, are reported in Figure 18a. The degradation is limited on the first 1 mm of depth from the external surface, with the presence of clear and thin crystals of gypsum (Figure 18b).

Figure 18- Micrograph of the PZ-L after 45000 hours of sulphate attack.

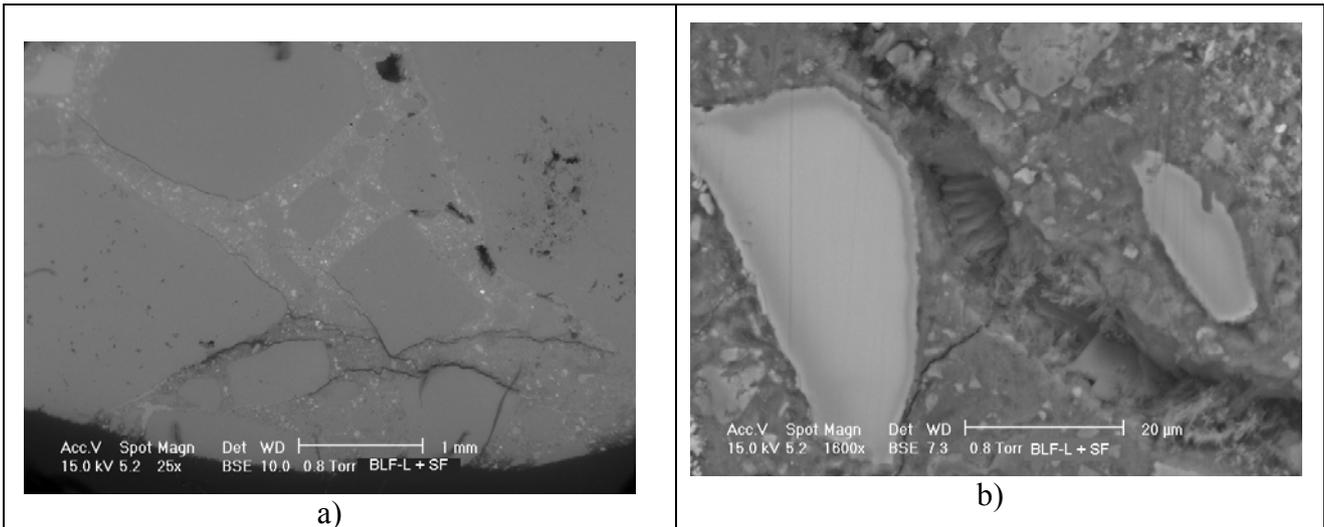
Figure 19 shows the microstructures of the sample produced with the BLF-L + SF during the cyclic acid/sulphate attack.

Figure 19 – Micrograph of the BLF-L + SF after 45000 hours of cyclic acid/sulphate attack.

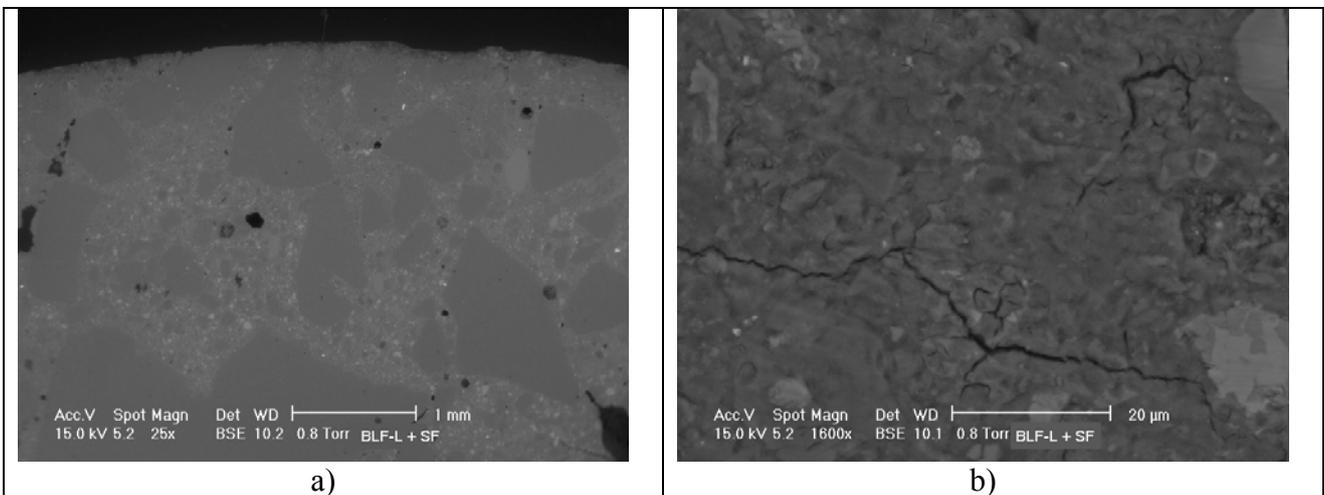
The combination of sulphate and acid attacks create only a few cracks in the external part of the section, differently from the sample subjected only to the sulphate attack, which doesn't show any sign of degradation (Figure 20). Only very thin and empty cracks are appeared on the section due to the cutting and polishing procedure.

Figure 20 – Micrograph of the BLF-L + SF after 45000 hours of sulphate attack.

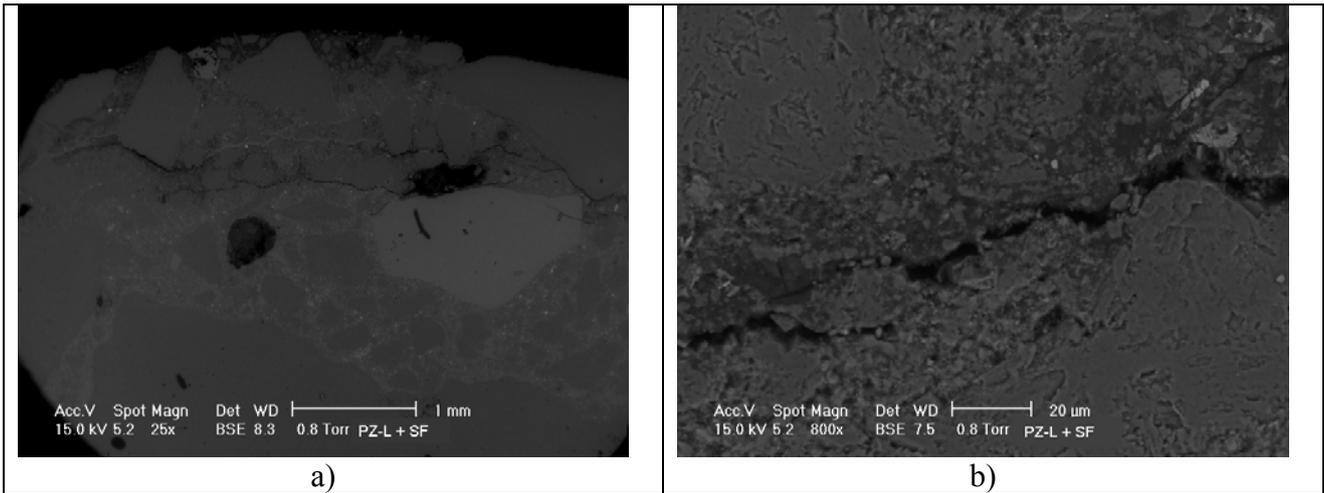
In Figure 22 is reported the microstructure of the PZ-L + SF after 45000 hours of sulphate attack. This specimen doesn't present any signs of degradation.

Figure 22 – Micrograph of the PZ-L + SF after 45000 hours of sulphate attack.

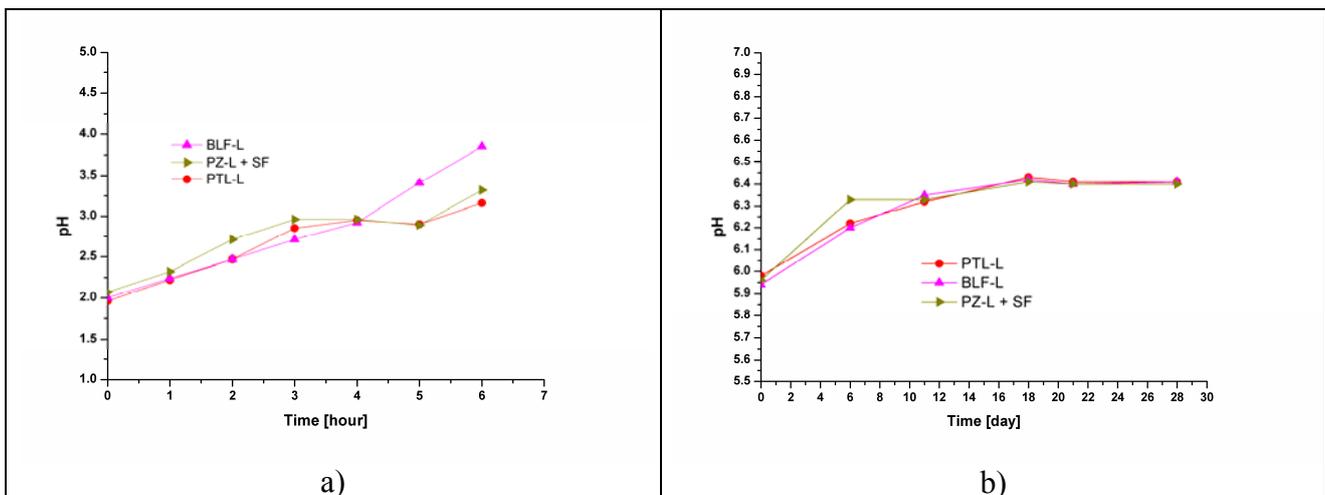
The pH values of all the solutions were checked during every types of attack and in Figure 23 is reported the trend during the 6 hours of acid attack (a) and during the 28 days of mixed sulphate attack (b).

Figure 23 – pH values during acid attack (a) and during complex sulphate attack (b)

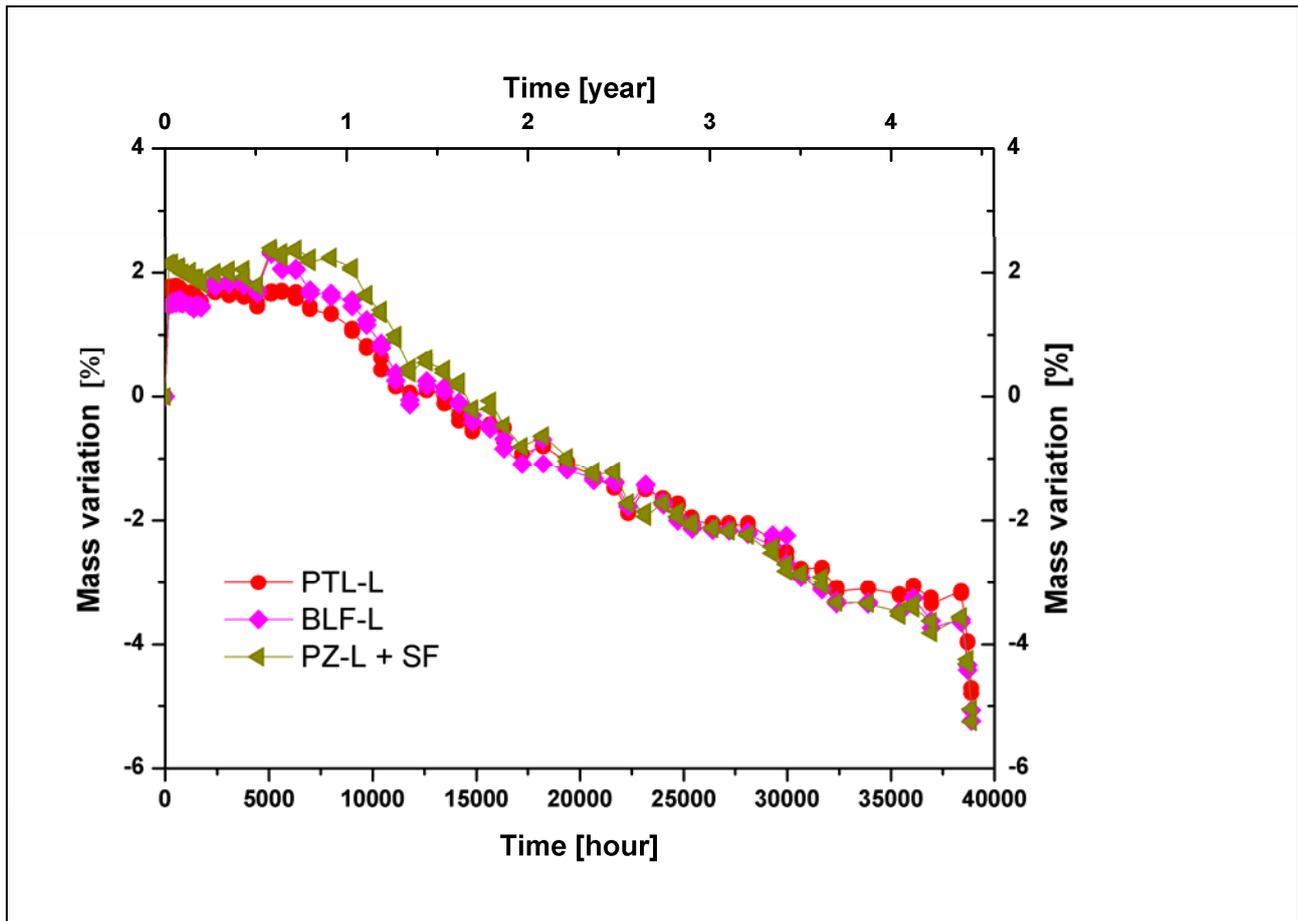
In Figure 24 the mass variation of the samples prepared with limestone aggregates during the sulphate attack is reported.

Figure 24 – Mass variation [%] during complex sulphate attack.

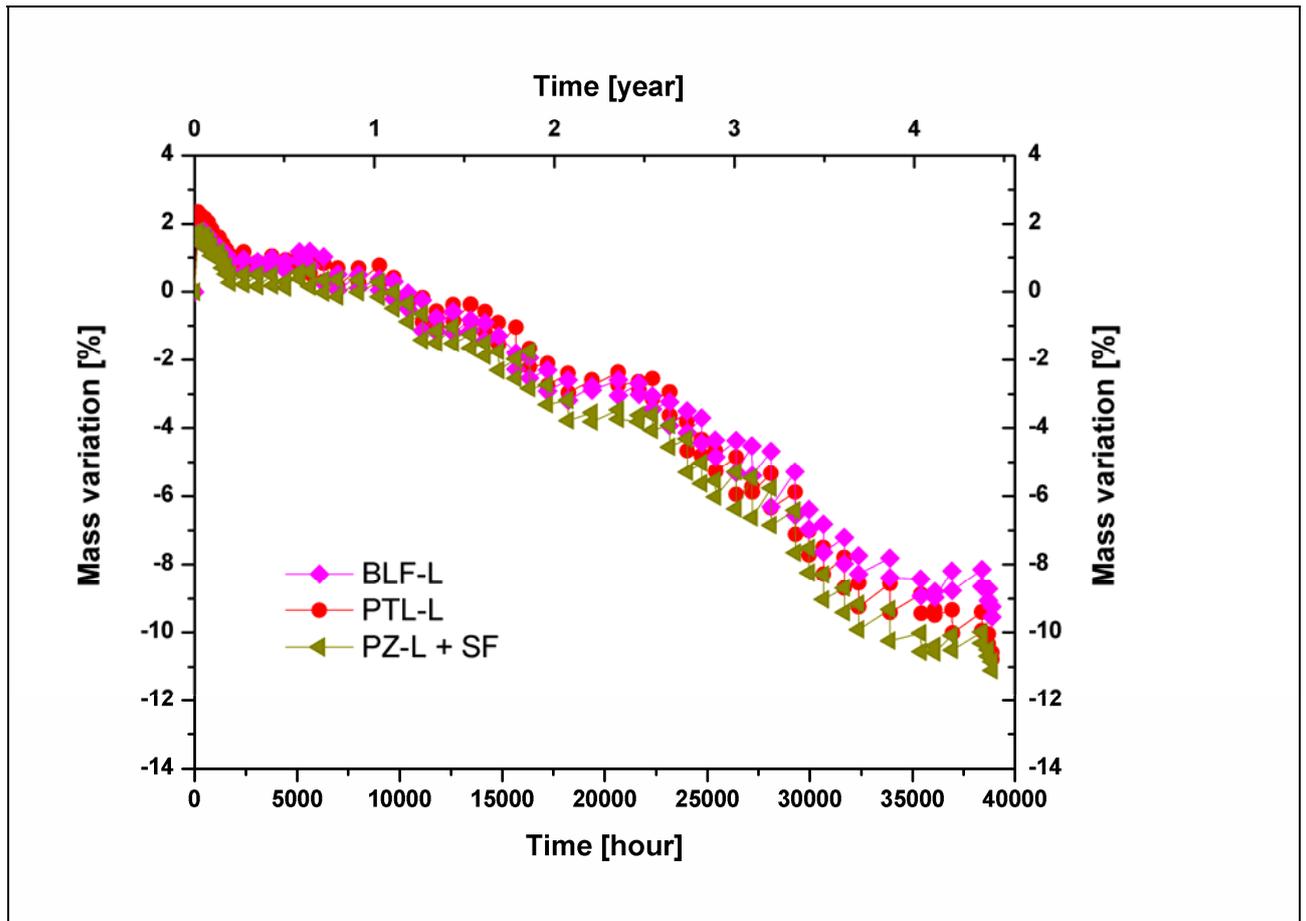
In Figure 25 the Δm of the samples during the cyclic acid/sulphate attack is reported. There are different behaviours: the first, for the first week, is a high incremental of the mass due to the absorption of the solution; the second, when the frequency of the attack is weekly, is a constant mass loss due to the effect of the acid attack; the third, is a quite mass loss, when the frequency of the attack is monthly, until 38000 hours.

Figure 25 - Mass variation [%] (mean value of three samples for each typologies) during the cyclic acid/(complex)sulphate attack.
