UNIVERSITY
OF TRENTO - Italy

Doctorate School in Materials Engineering – XXI cycle

Studies on concrete degradation in aggressive environment and development of protective system

Fabrizio Girardi

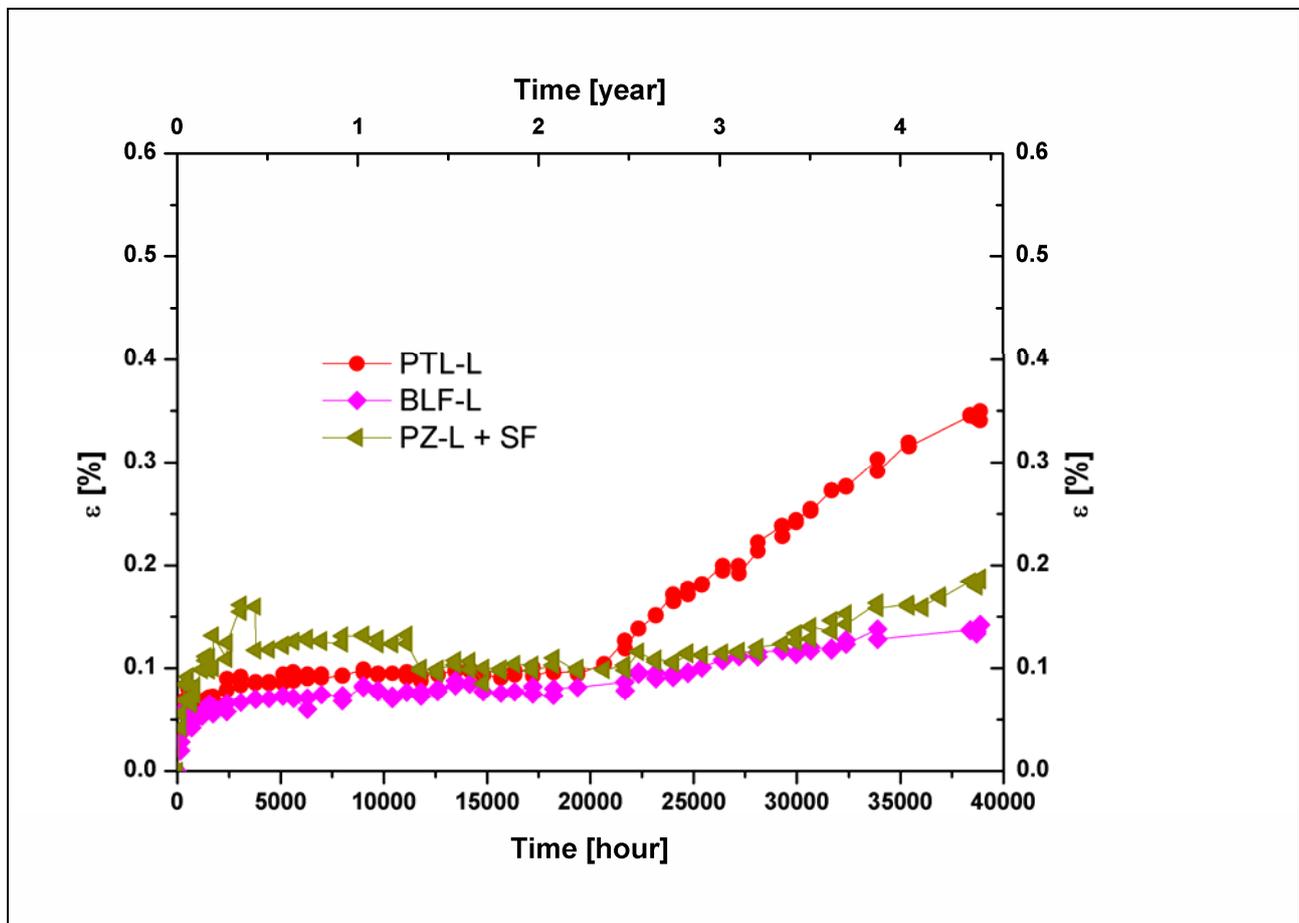
In Figure 26 the percentage deformation during the sulphate attack is reported. After the initial deformation due to the solution absorption, no expansion was recorded 20000 hours with no deformation for all the three mixtures.

Figure 26 – Deformation [%] during the complex sulphate attack.

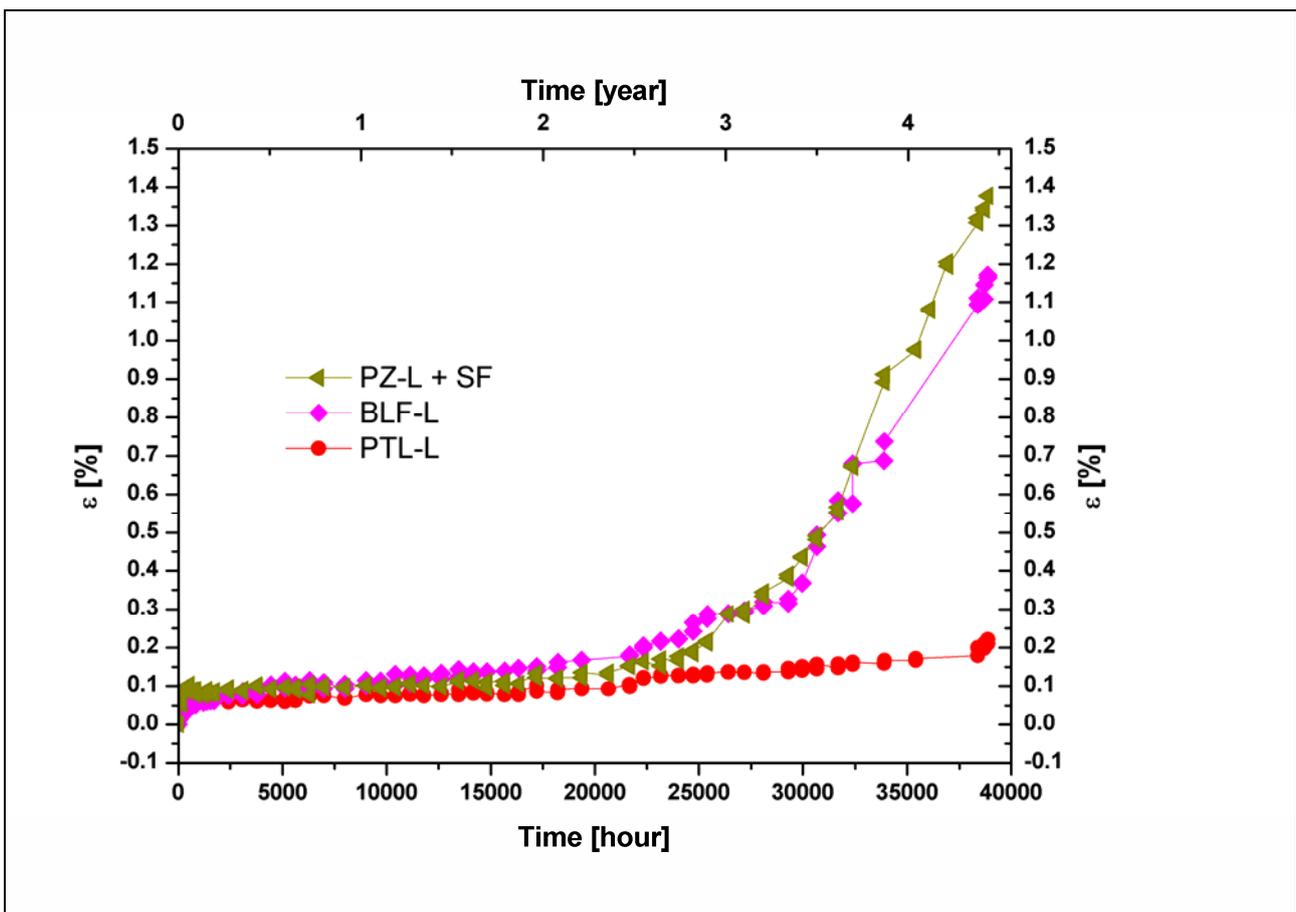
In Figure 27 the expansion of the specimens subjected to the cyclic acid/sulphate attack is reported. Similarly to the sulphate attack, a deformation is recorded during the first weeks due to the solution absorption. Subsequently, no significant change of length occur until 20000 hours of analysis (induction period), unless PTL-L.

Figure 27 – Deformation [%] (mean value of three samples for each typologies) during cyclic acid/(complex) sulphate attack.

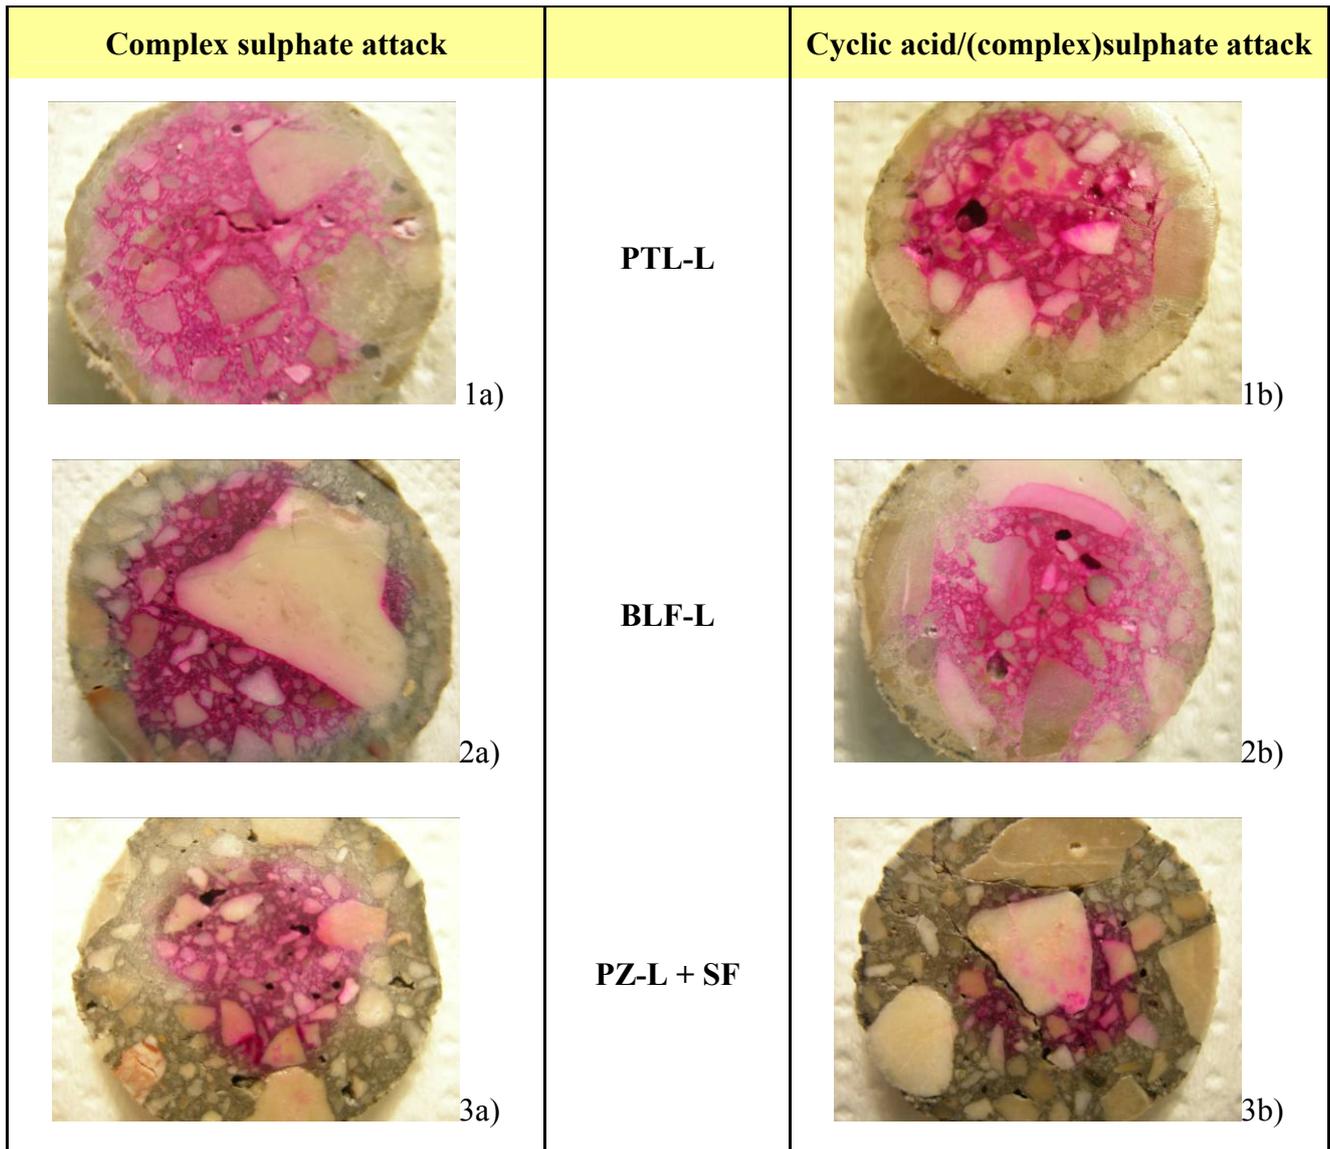
Figure 28 shows the results of the phenolphthalein test. In the column on the left, there are the micrographs concerning the samples after the sulphate attack and on the right the micrographs regarding those subjected to the cyclic acid/sulphate attack. In the PTL-L (1a) alkalinity is acceptable after the sulphate attack, but in the other case an external layer of about 3 mm, doesn't show the pink colour. The same phenomena are obtained with the BLF-L (see 2a and 2b in the figure) and with the PZ-L + SF (3a and 3b in the figure). In this last case, only an area of the cutting section with about 10 mm of diameter has an acceptable response.

Figure 28 - Phenolphthalein methods results (EN 9944)

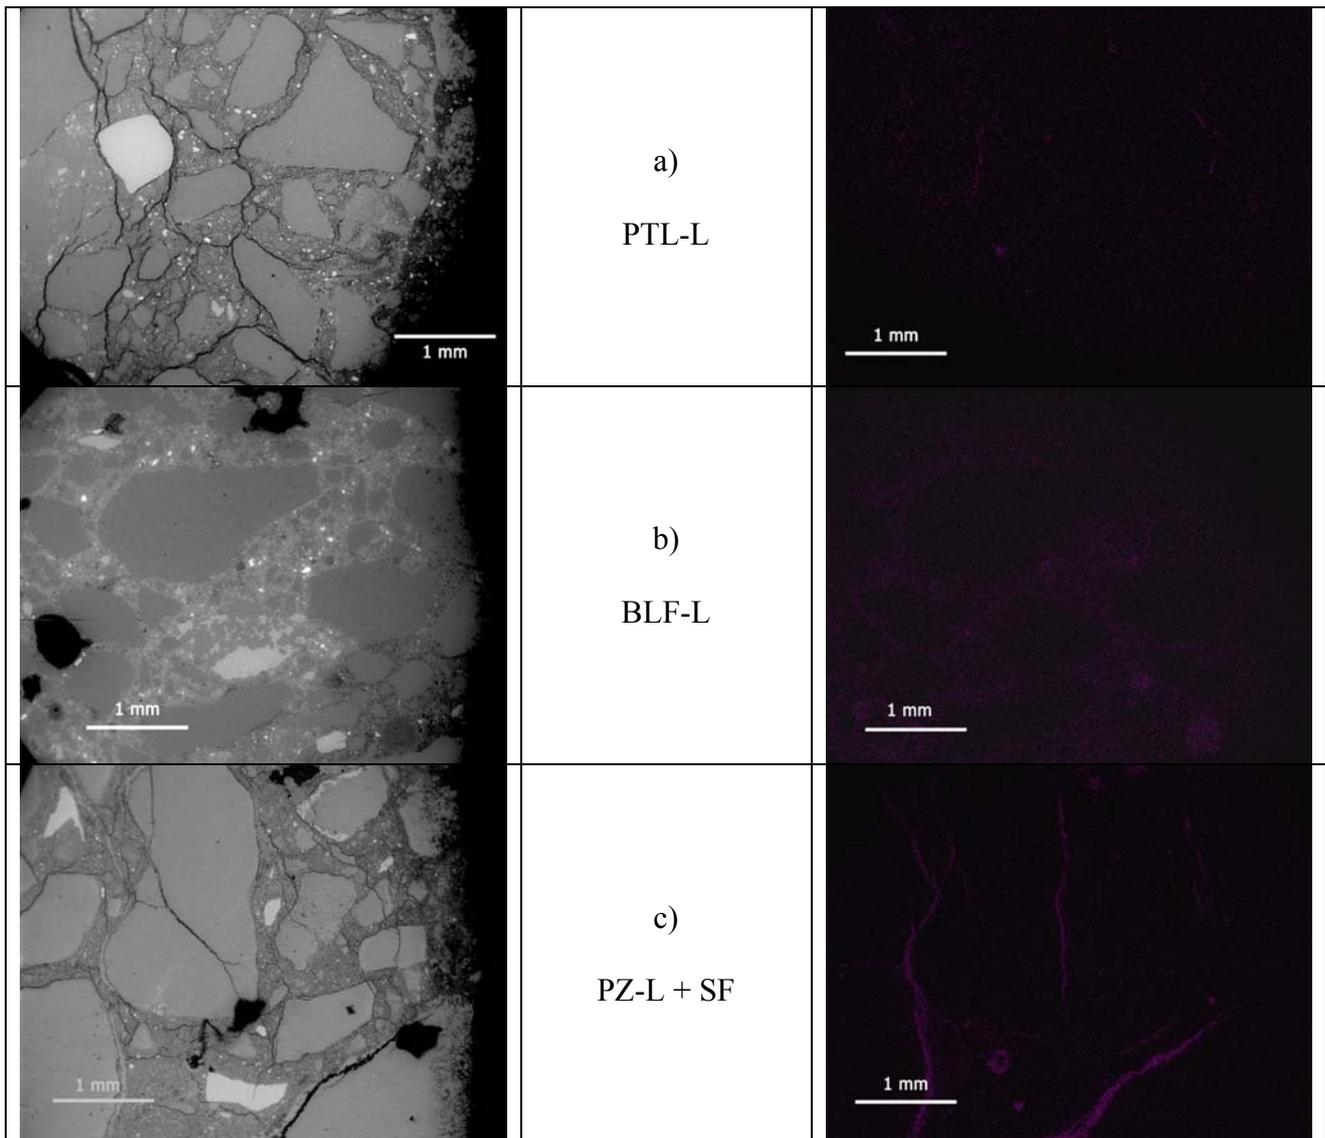
Many of the internal cracks were filled with columnar crystals. The X-ray maps indicate sulphur in the cracks, so that after that the acid attack favours the microcracks formation afterwards sulphate phases crystallize.

Figure 29 ESEM images (on the left) and X-ray maps for sulphur (on the right) of polished surface subjected to cyclic acid and complex sulphate attack.

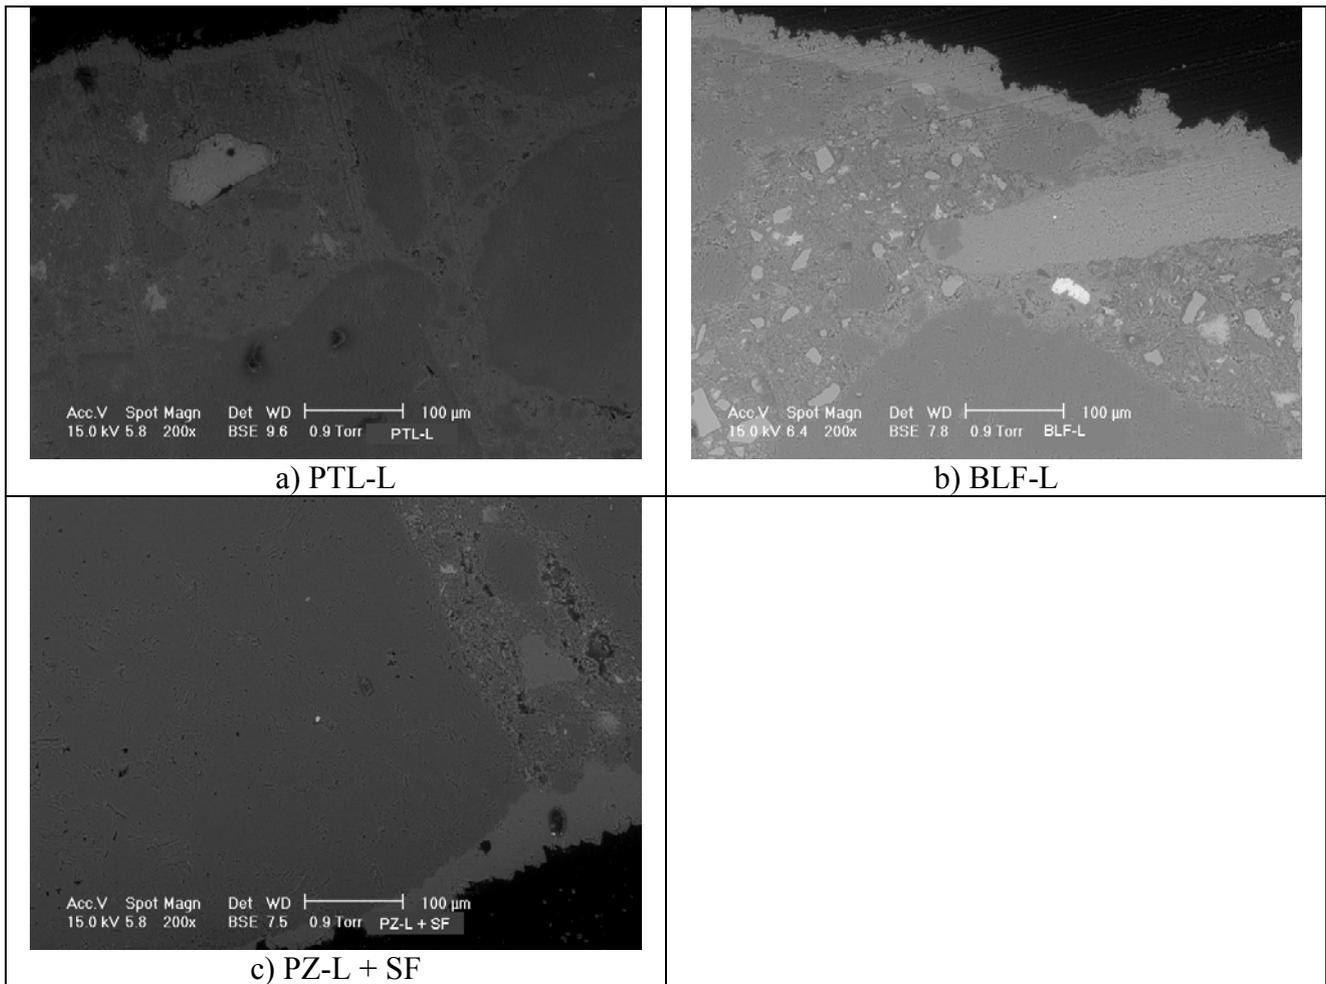
In the Figure 37 the micrographs analysis of the specimens, stored in water for all the time are reported. The sample doesn't show signs of attack as cracks, but only a thin layer (light grey in the figure) on the external surface rich of Ca and C as measured by the EDAX analysis. This layer (30-40 μm) affected by carbonation. The microstructure is the same in all the analysed samples.

Figure 37 – Micrograph of the mixtures stored in water after 40000 hours.

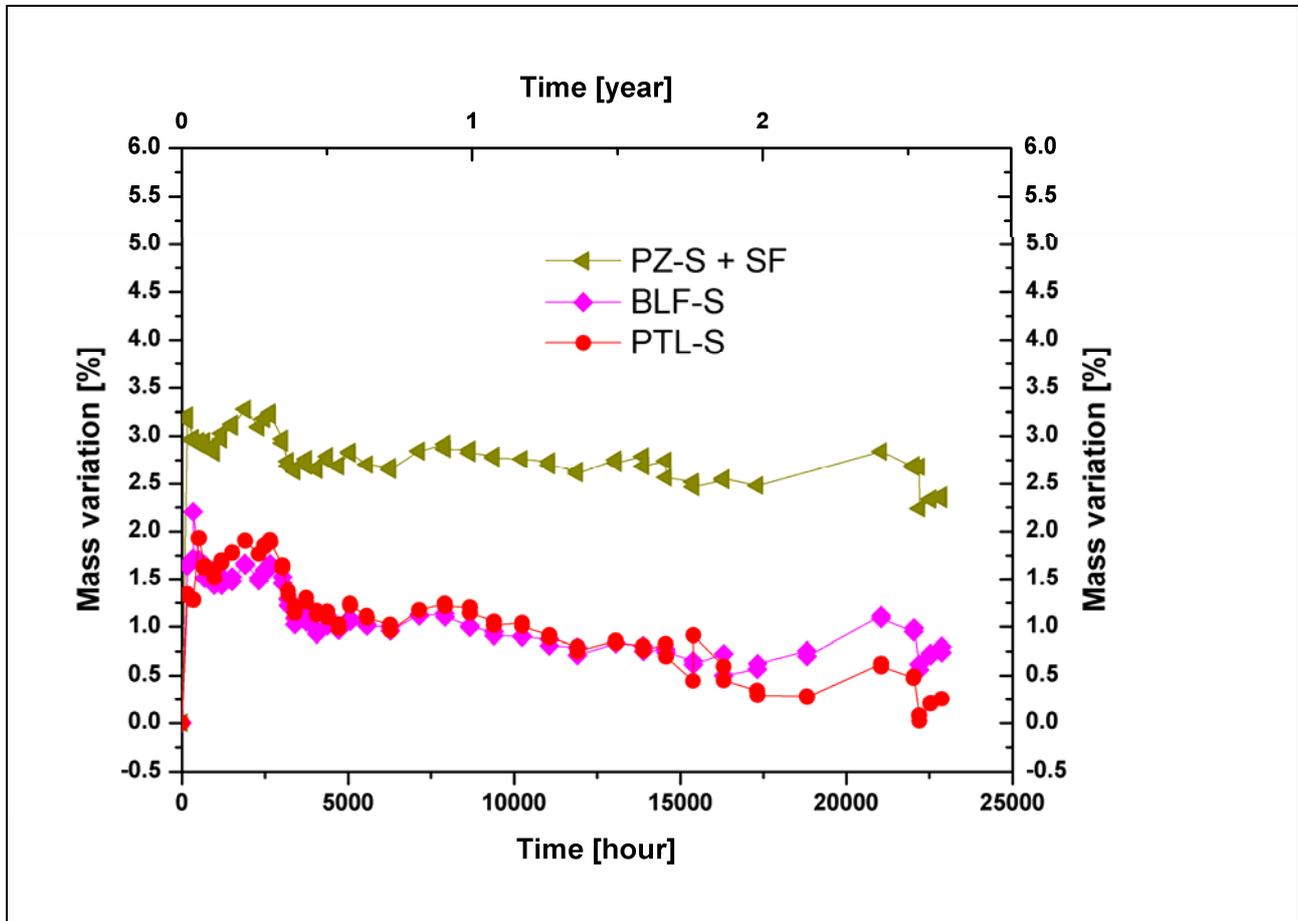
In Figure 39 the mass variation vs. time of the samples during the sulphate attack is reported.

Figure 39 – Mass variation [%] during the complex sulphate attack (mean value of two samples).

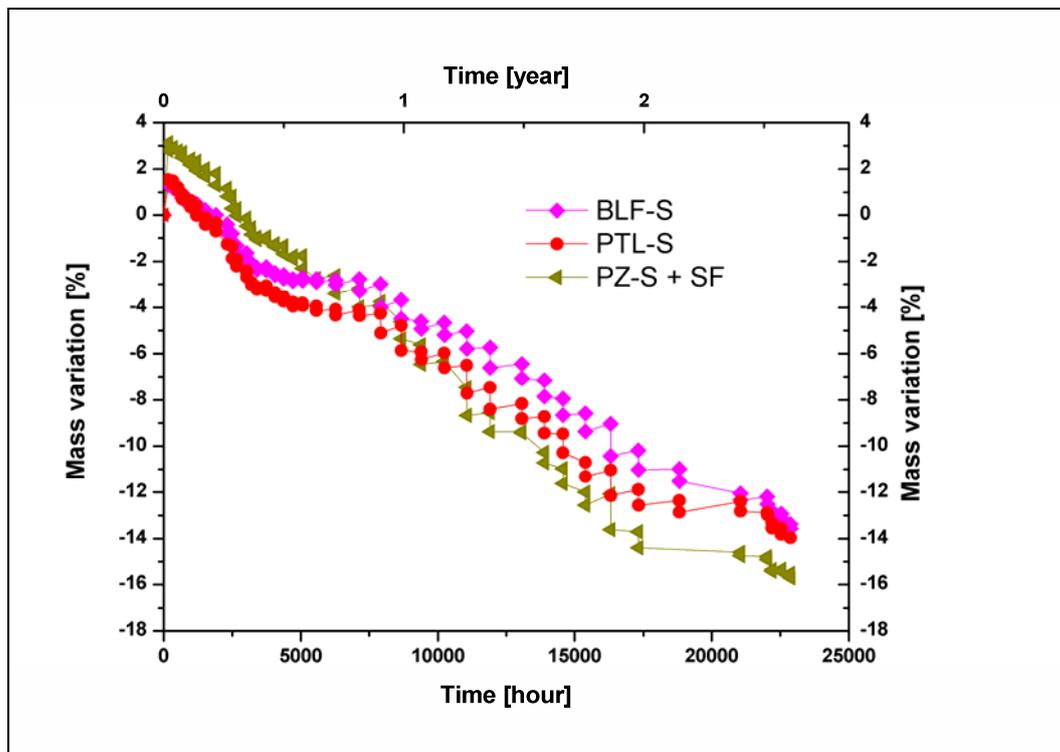
The Δm during the cyclic acid/sulphate attack is reported in Figure 40. After 2.5 years, all the typologies of mixtures have a high mass loss and, in particular, the mixture PZ-S + SF shows $\Delta m = -16\%$ whereas the others two show $\Delta m = -14\%$.

Figure 40 – Mass variation [%] during the cyclic acid/(complex) sulphate attack (mean value of two samples).

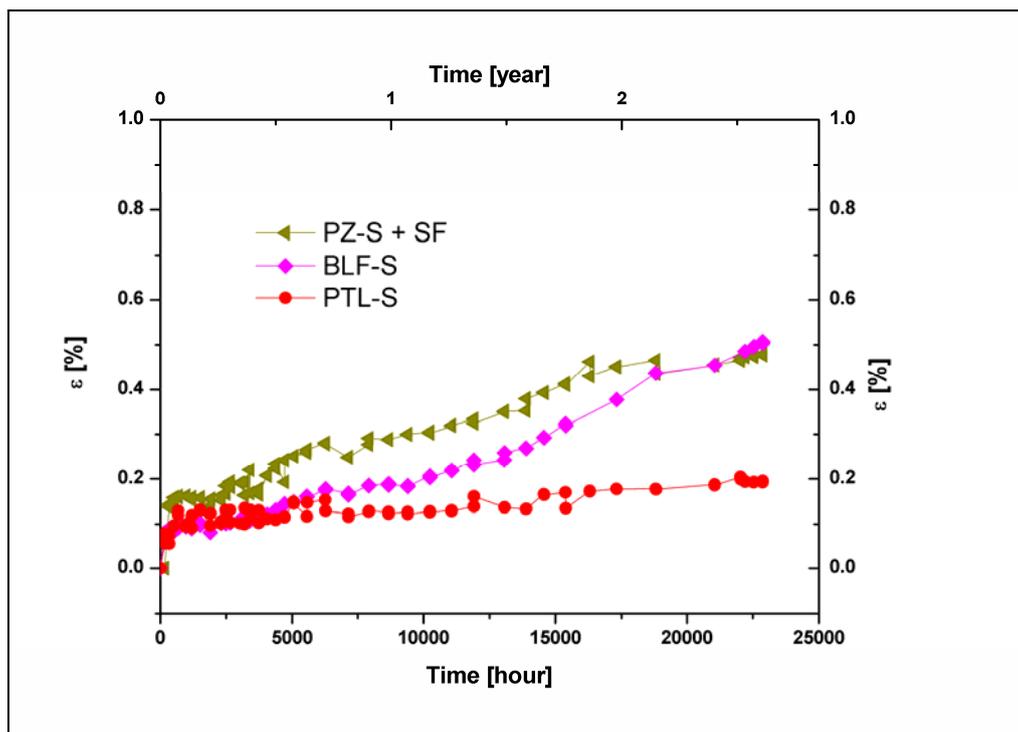
The deformation vs. time during the only sulphate attack is reported in Figure 41. The mixture PZ-S + SF started to expand already in the first week.

Figure 41 – Deformation [%] during the complex sulphate attack (mean value of two samples).

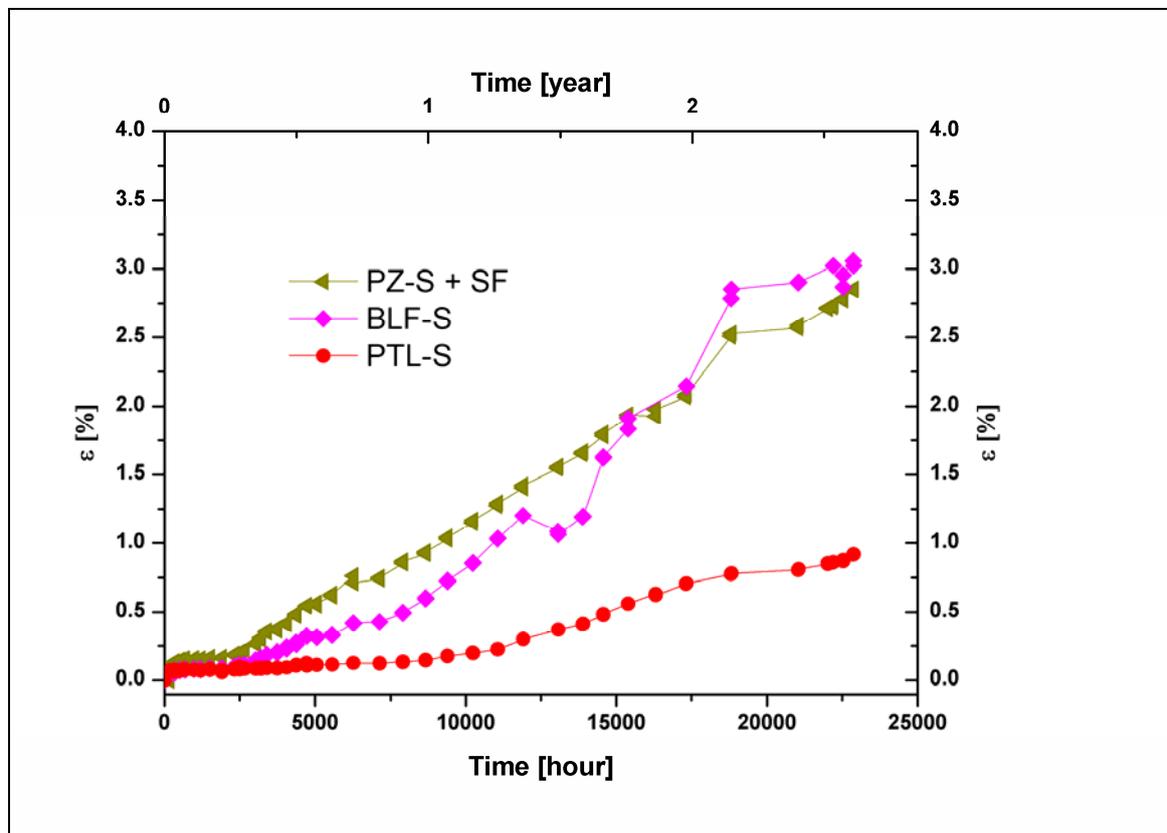
In Figure 42, the deformation during the cyclic acid/sulphate attack is reported. After the initial absorption of the solution, a period without any length variation followed.

Figure 42 – Deformation [%] during the cyclic acid/(complex) sulphate attack (mean value of two samples).

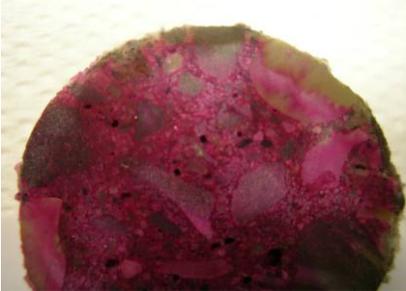
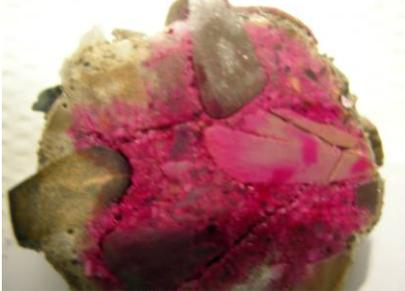
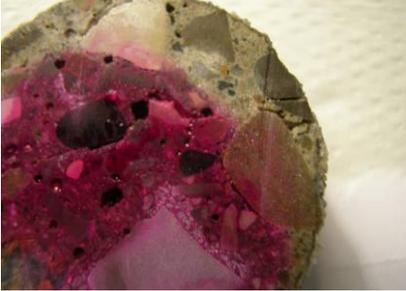
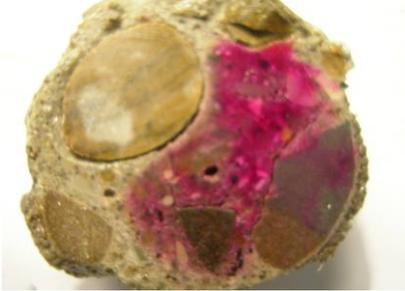
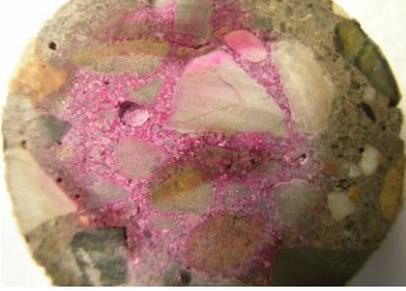
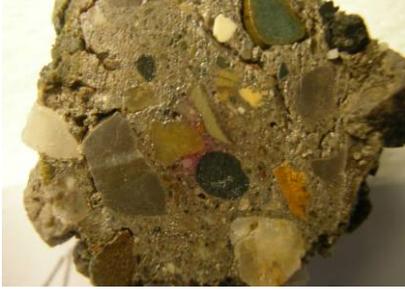
Figure 43 - Phenolphthalein methods (EN 9944) results on concretes prepared with silicates aggregate.

Figure 43 shows the results of the phenolphthalein test. On the column on the left, there are the micrographs concerning the samples after the sulphate attack and on the right the micrographs regarding those subjected to the cyclic acid/sulphate attack.

Complex sulphate attack		Cyclic acid/(complex)sulphate attack

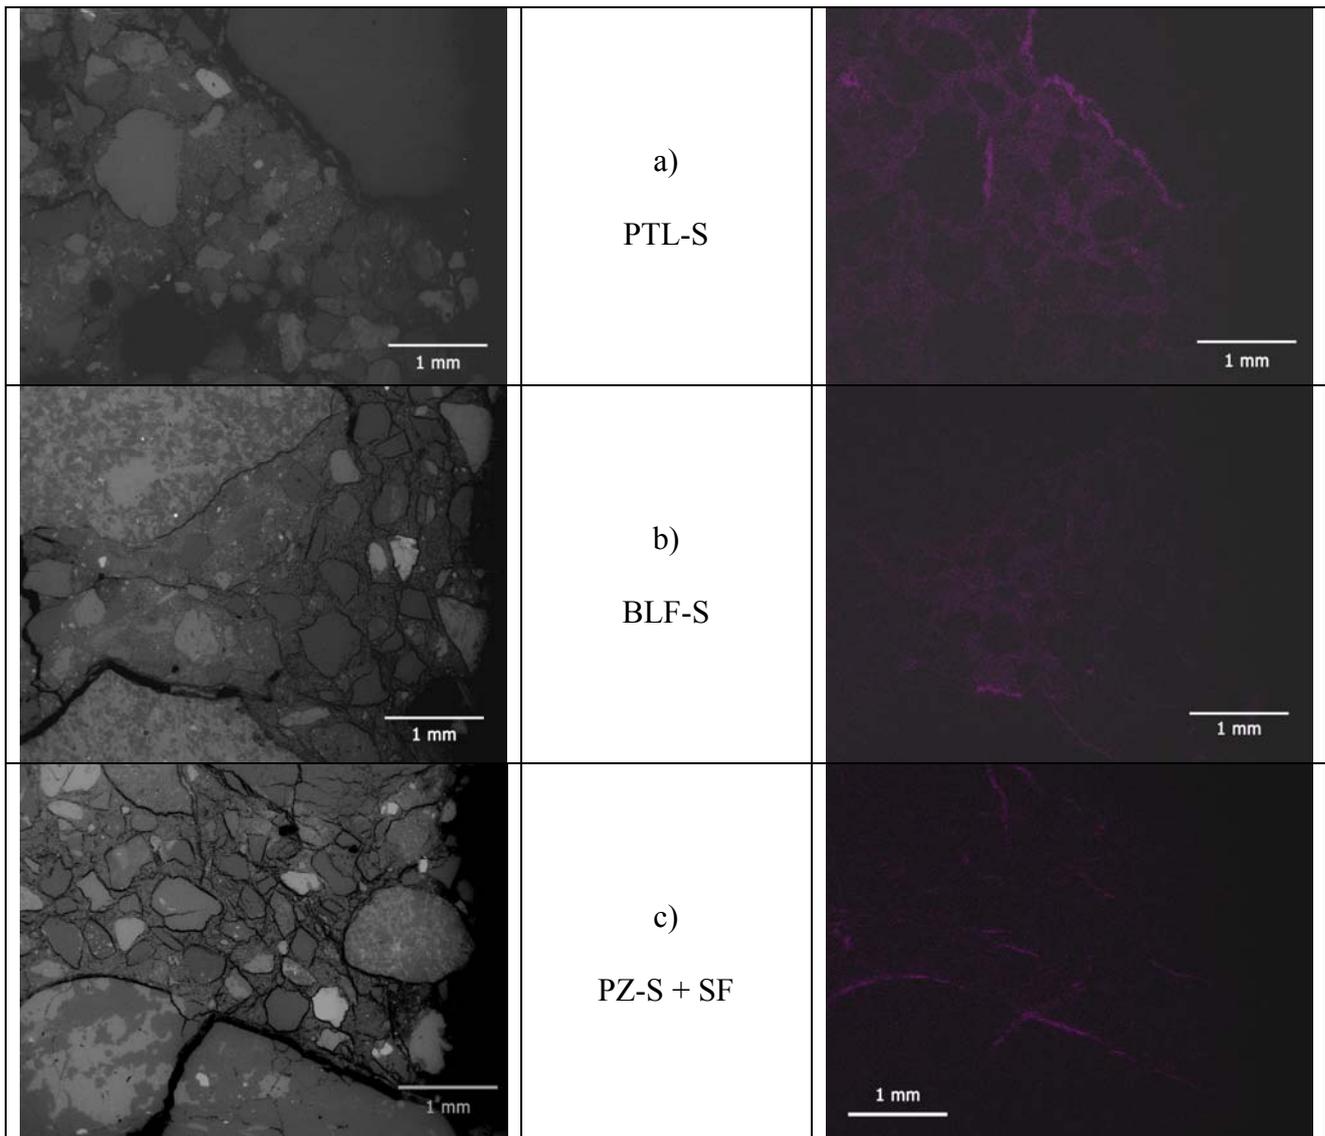
For the PTL-S sample (Figure 44a), the surface doesn't show cracks neither a preferential path of the acid attack, which seems instead to provide a general erosion of the surface. This is confirmed by the X-ray map for sulphur of the same sample: there is no evidence of cracks and the sulphur is present in the voids and entrained air bubbles and on the external surface. The cutting surface of the sample BLF-S (Figure 44b) a few cracks appear in the cement paste. As it can be seen in the corresponding X-ray map, the sulphur is present everywhere especially in the cracks. The micrograph of the PZ-S + SF sample (Figure 44c) shows an extensive cracking, observed around aggregates and through the paste, with occasional cracking through aggregate particles. The most of cracks appears black, due to the loss of material during the cutting and polishing of samples.

Figure 44 - ESEM images (on the left) and X-ray maps for sulphur (on the right) of polished surface subjected to cyclic acid and complex sulphate attack.

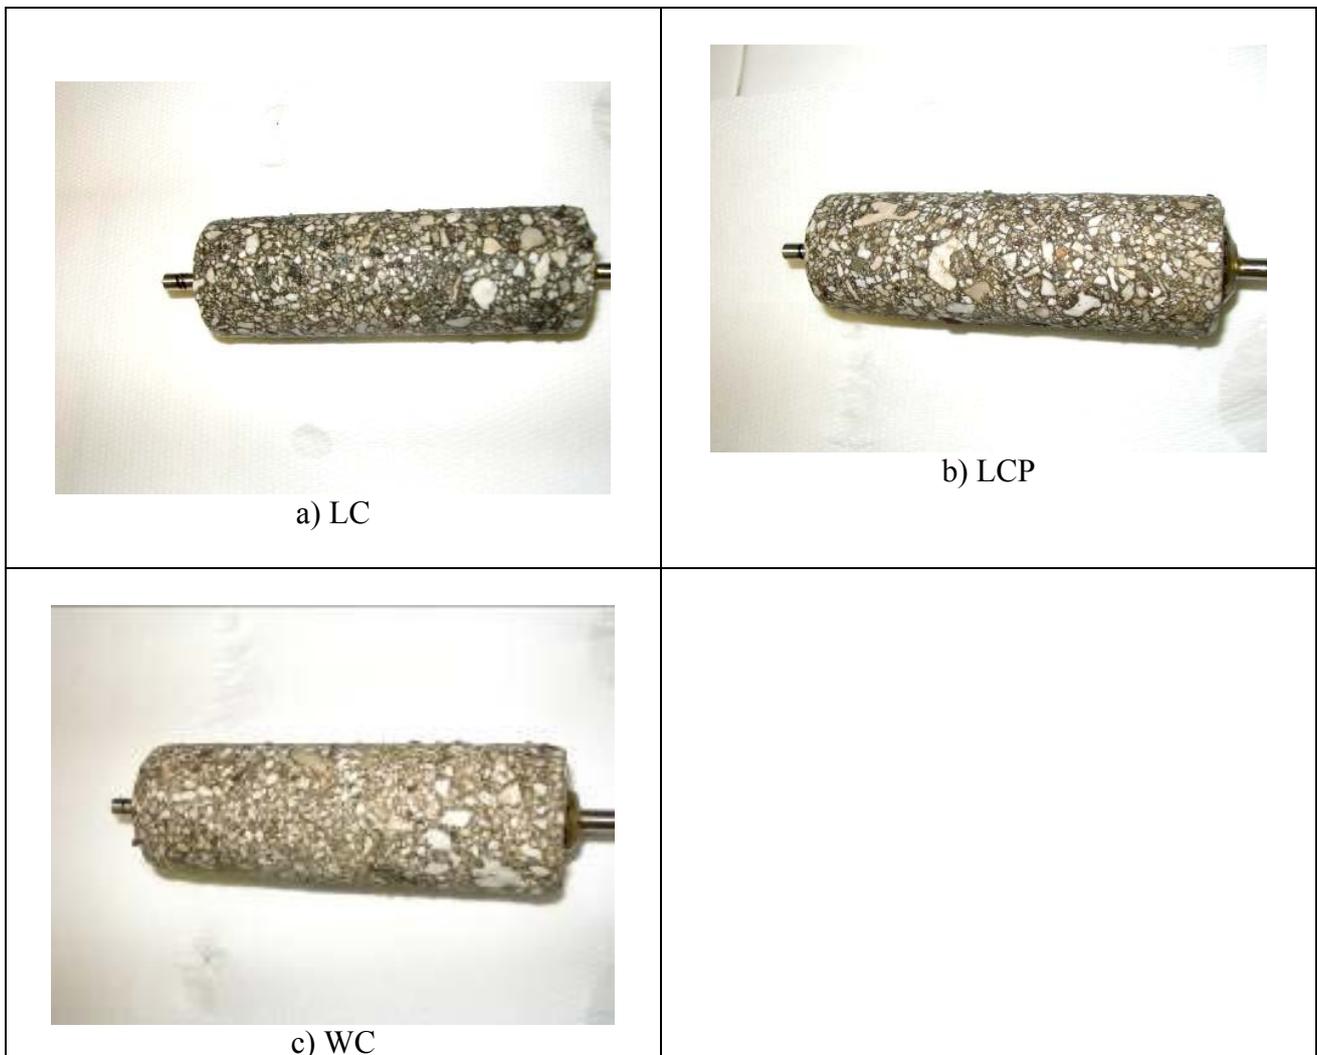
Figure 58 – Effect of the silica coating on the grow of algae.

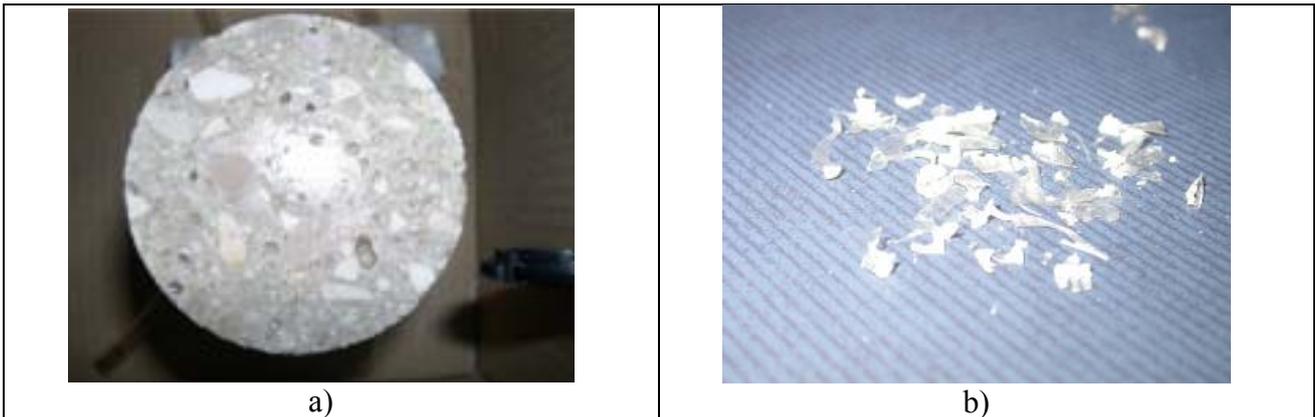
Figure 59 – Silica coating applied on hardened concrete.

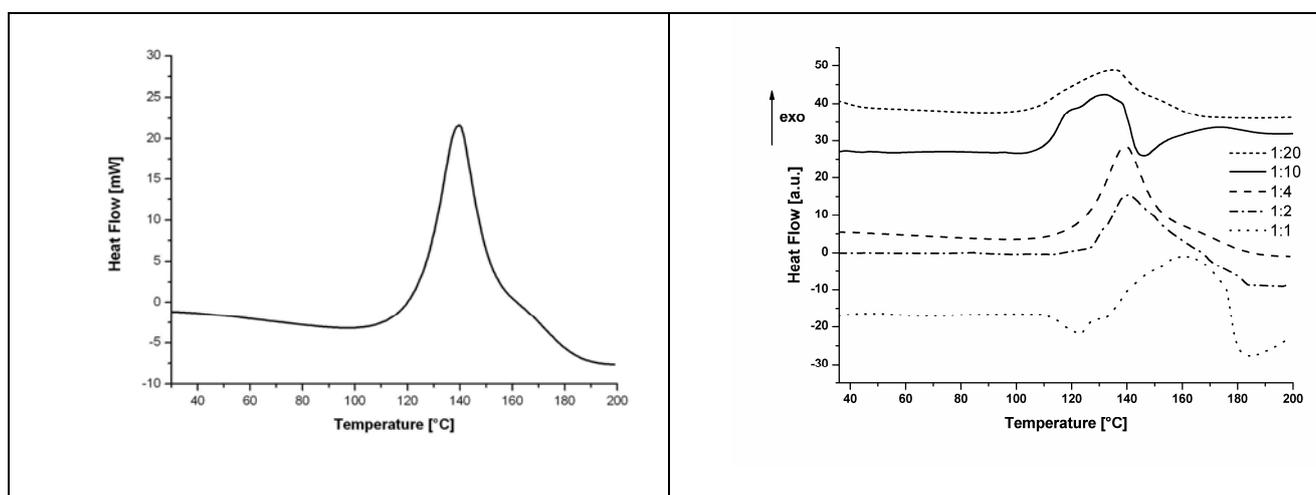
Figure 62 - DSC curve of the solution VTMS/ZrNBB/BPO; Zr:Si 1:4 on the left; different ratio on the right.

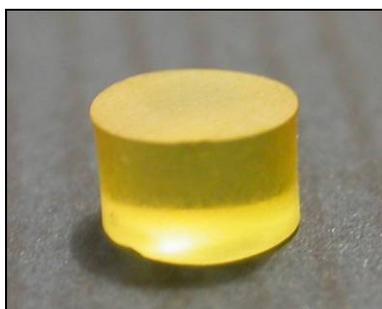
Figure 63 – Bulk sample obtained heating the xerogel up to 130°C for 1 h

As a consequence, the choice of polymerization parameters, such as the temperature or time, can affect the polymerization degree and accordingly the final properties of the hybrid polymer. In this chapter, bulk samples were obtained heating the xerogel up to 130°C, after an isothermal step at 90°C. This thermal treatment produces a glassy dense hybrid material as presented in Figure 63, where the typical cylinder used for the thermo-mechanical test is shown.

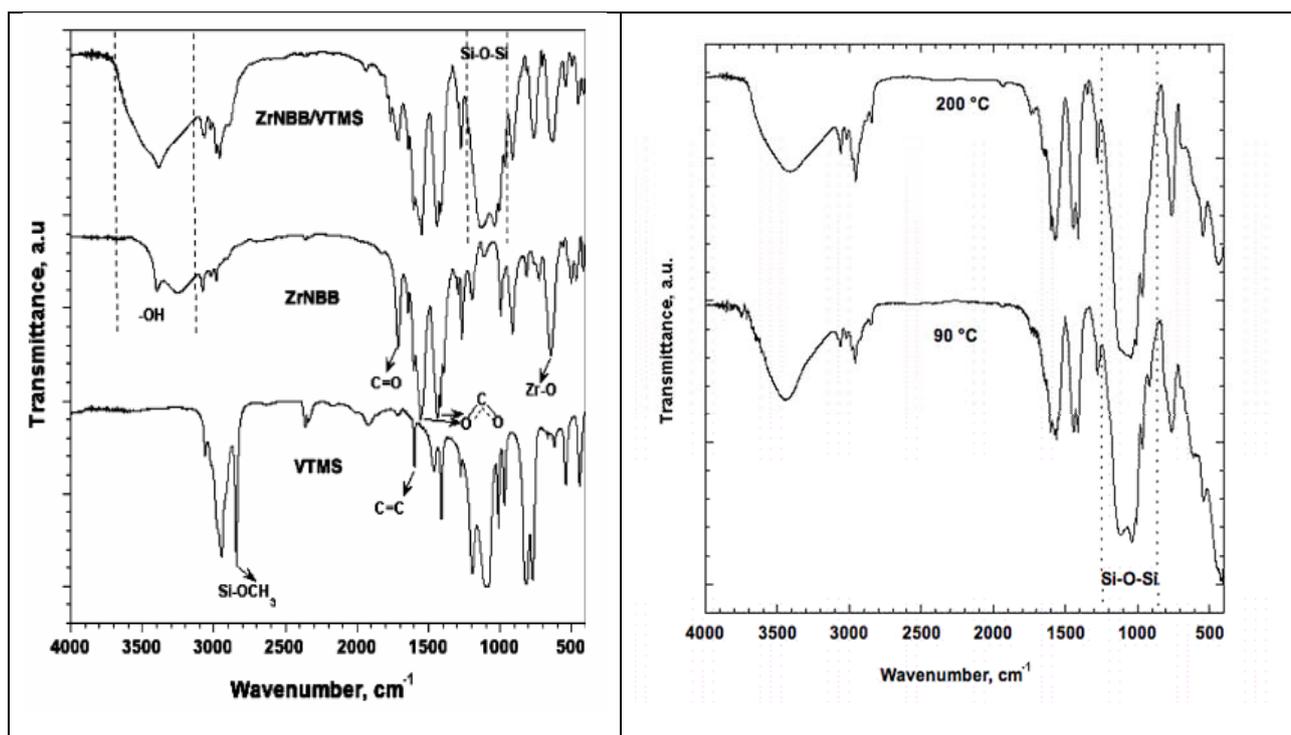
Figure 64 - FTIR spectra of reagents (ZrNBB and VTMS) and hybrid gel

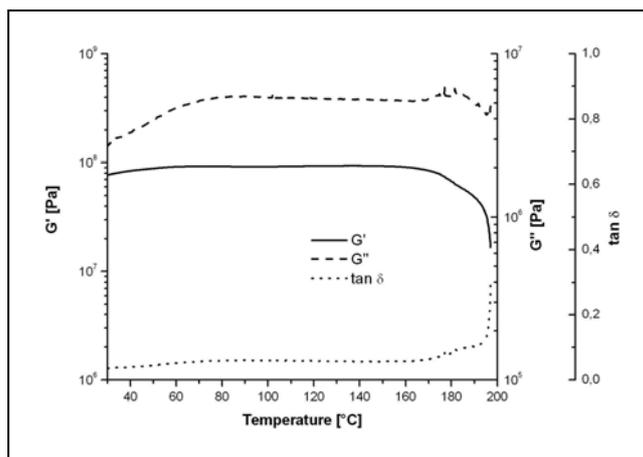
Figure 66 - Viscoelastic properties of sample ZrNBB/VTMS (Zr:Si 1:4) hybrid material vs. temperature

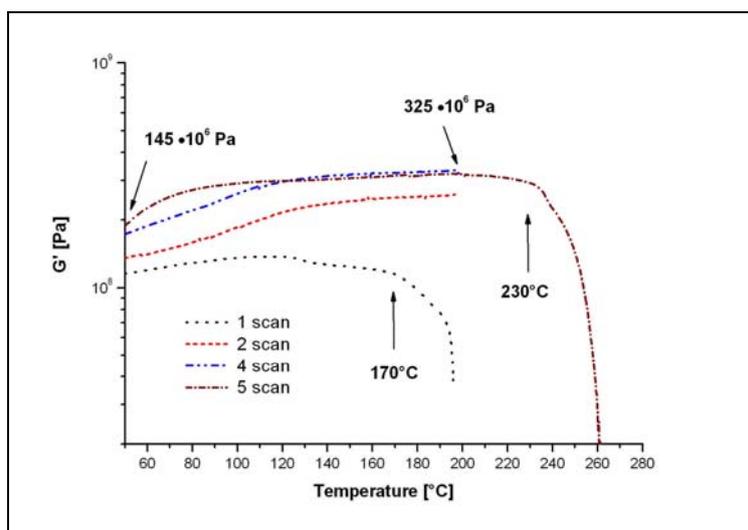
Figure 67 - Storage modulus (Zr:Si 1:4) vs. temperature of the same samples, subjected to five consecutive DMS tests
